Home and Building Services, inc.

Consult Address: ##### East XXXXX Avenue
XXXXX, WA

Consult Date: September 11, 20XX
Consult Focus: Apartment Investor Inspection Summary

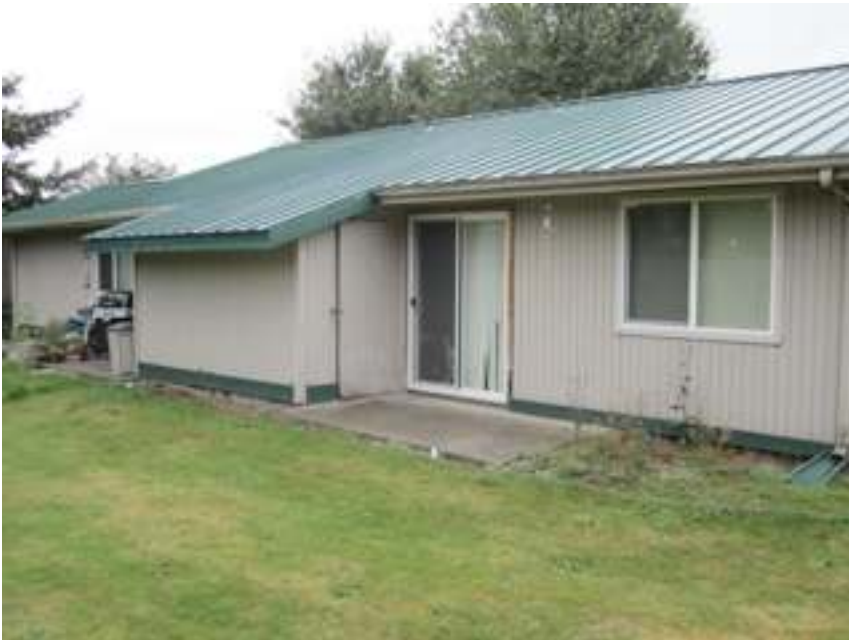
The **storage closets** on the west side units have suffered the most weather damage, again due to the wind and rain exposure. This includes the south facing access doors. The west siding has large amounts of roof drainage on the plywood due to the lack of gutters at the outside wall. Installation of gutters and a downspout should limit the need for ongoing siding replacement, where currently a higher rate of failure and repairs were observed.

typical back side of units
note extended roof line, over storage, without gutter

- 5.3.2. extensive plywood damage & ongoing repairs due to regular water exposure
 - 5.3.3. weather / rain damaged store room doors, south facing
 - 5.3.4. *recommend installing gutters & downspouts to all west side storage units*

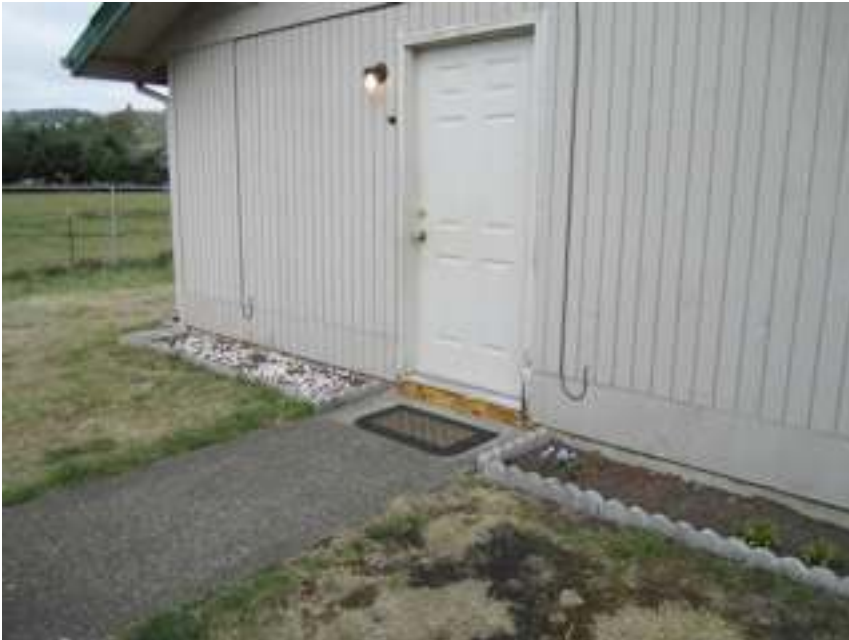
The **entry doors**, on the south sides, have a strong weather exposure and several have been replaced. In most cases the trim has not been installed properly or painted, with the exception of the factory priming. Repairs and replacement are needed on many of the doors.

typical apartment entry, note missing threshold trim

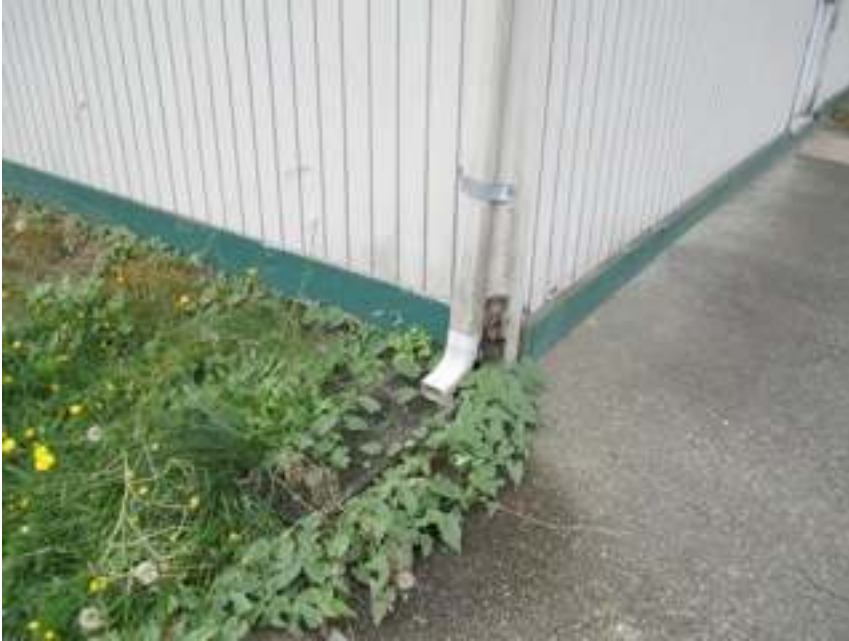
Extensive **soil contact** was observed at the base of the siding and bellyband trim throughout the project. This needs to be corrected and maintained to prevent additional ongoing damage and decay.

typical earth wood contact & siding damage w/ rot behind downspout

- 5.2. extensive earth / wood contact @ base of siding, most units:
 - 5.2.1. *correct & maintain*
- 5.3. damaged siding & store room doors:
 - 5.3.1. missing gutters & downspouts @ outside walls of storage units:

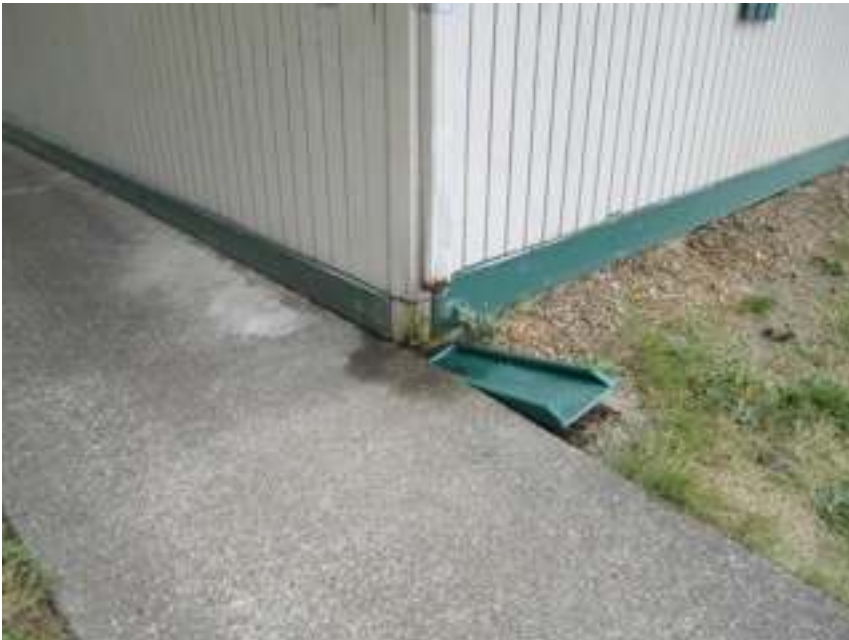
The **gutters and downspouts** need attention. Most of the downspouts are the original galvanized material with rust and deterioration. Several have missing parts, allowing water to drain on the siding creating damage, others were not installed with proper slope to allow good flow and prevent leaking. Note some of the parts were installed improperly with the slip fittings backwards allowing additional leaking. I recommend replacing all of the downspouts with new aluminum downspouts and fittings as well as properly aligning and supporting the splash blocks for proper drainage away from the foundation and secured against accidental movement. Several of the buildings need the gutter cleaned.

- 5.3.5. *remove & repair all damaged storage room doors & siding*
- 5.4. drainage:
 - 5.4.1. downspouts
 - 5.4.1.1. many buildings w/ missing parts & transitions

- 5.4.1.2. water draining on siding & trim
 - 5.4.1.3. poorly located & secured splash blocks
 - 5.4.1.4. improperly assembled downspouts & poorly sloped sections

typical downspout w/ missing parts, poor splash block positioning & siding damage

- 5.4.1.5. most w/ heavy rust
 - 5.4.1.6. *remove & replace all downspouts & re-position splash blocks*
 - 5.4.2. gutters:
 - 5.4.2.1. *clean & flush; maintain regularly*

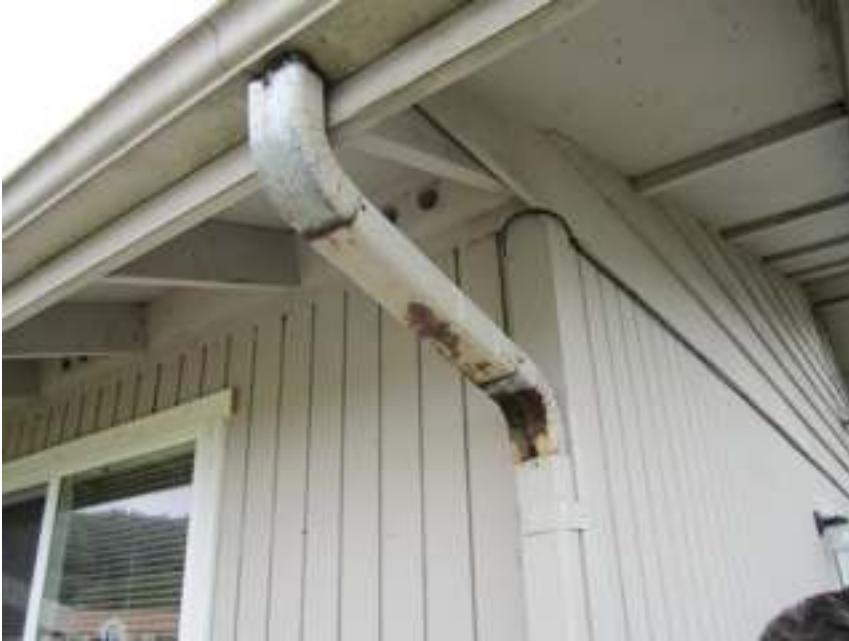
typical downspout rust

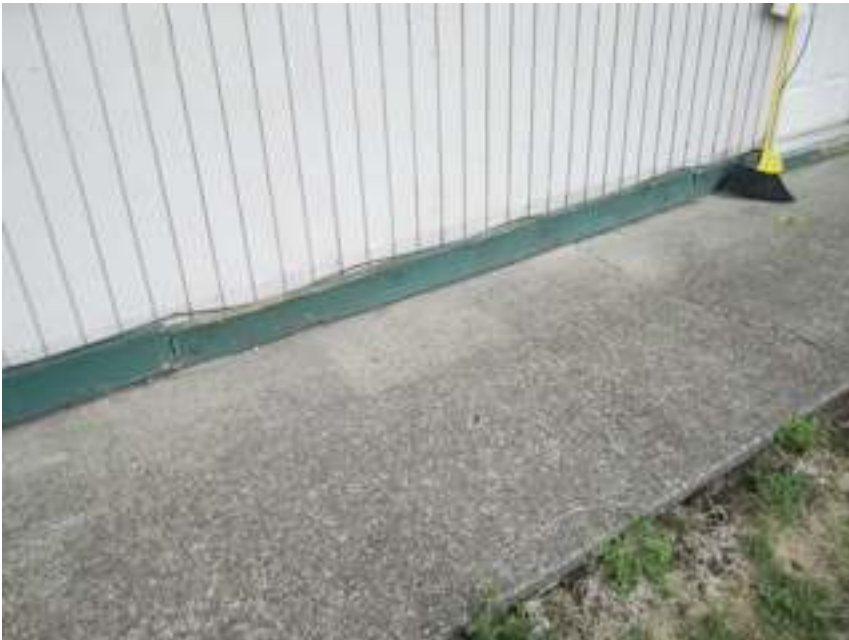
The buildings have a band of trim installed around the base of the siding, commonly referred to as a bellyband. This has been improperly installed allowing water to pass between the trim and siding causing decay and rot. All of this material should be removed and the T-1-11 replaced as needed. In areas where the band is desired, or used as the replacement of the damaged siding, proper flashing should be installed behind the plywood and over the top of the bellyband. This band should be pressure treated 2x material to limit decay when soil is in contact.

- 5.1. fungal rot / decayed T-1-11 plywood siding:
 - 5.1.1. bottom portion of plywood panels w/ moisture trapped behind bellyband trim
 - 5.1.2. missing proper flashing to divert water over the top of bellyband

typical bellyband damage w/ decay behind trim

- 5.1.3. most units w/ heavy damage to south exposures & west side storage units
 - 5.1.4. *recommend removal of all bellyband, remove all damaged siding, install flashing behind bottom edge of plywood & over top of new treated trim*

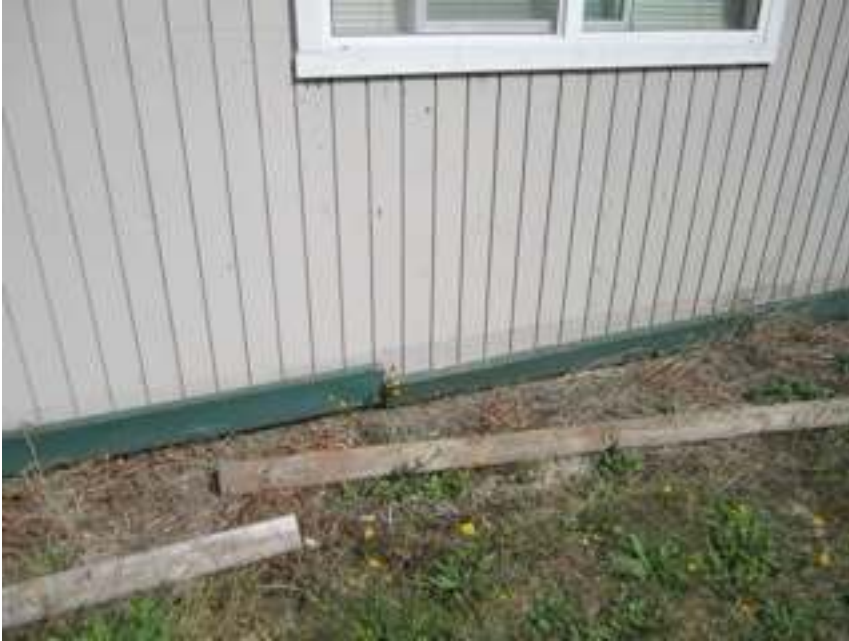
typical loose bellyband w/ fungal rot / decay behind missing flashing to prevent water behind trim

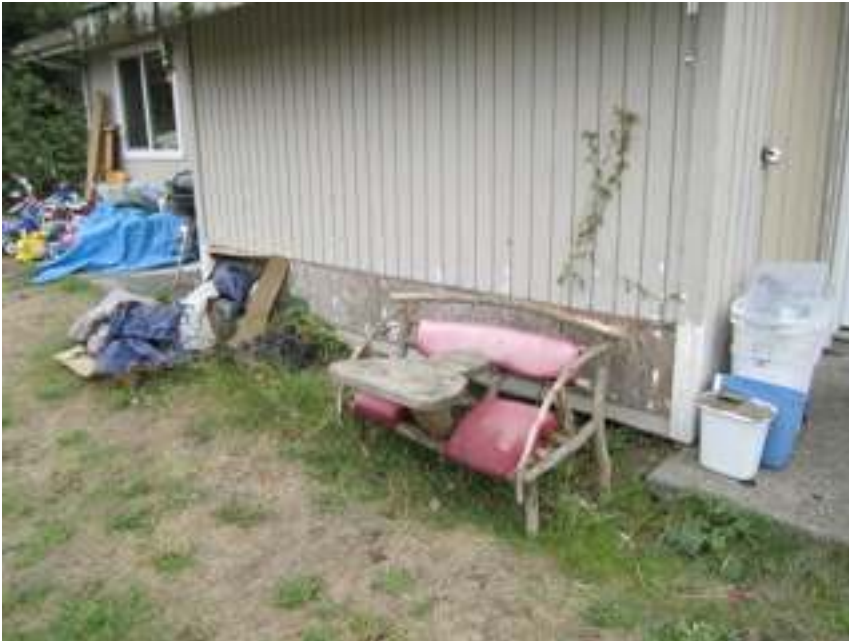
Several of the buildings have had basic repairs performed, likely to replace damaged and rotted siding. Most of this work still needs to have paint to complete the work and protect the materials from weather damage.

- 5.5. paint:
 - 5.5.1. siding past due for paint to protect siding
 - 5.5.2. entry door trim damage due to lack of paint
 - 5.5.3. ongoing siding repairs w/ little or no paint to preserve new siding

previous siding repairs to storage shed siding missing paint to prevent on going water damage

- 5.5.4. *recommend complete painting of all unit exteriors*
- 5.6. Unit 30:
 - 5.6.1. fungal growth on south side plywood siding
 - 5.6.1.1. note interior drywall damage observed

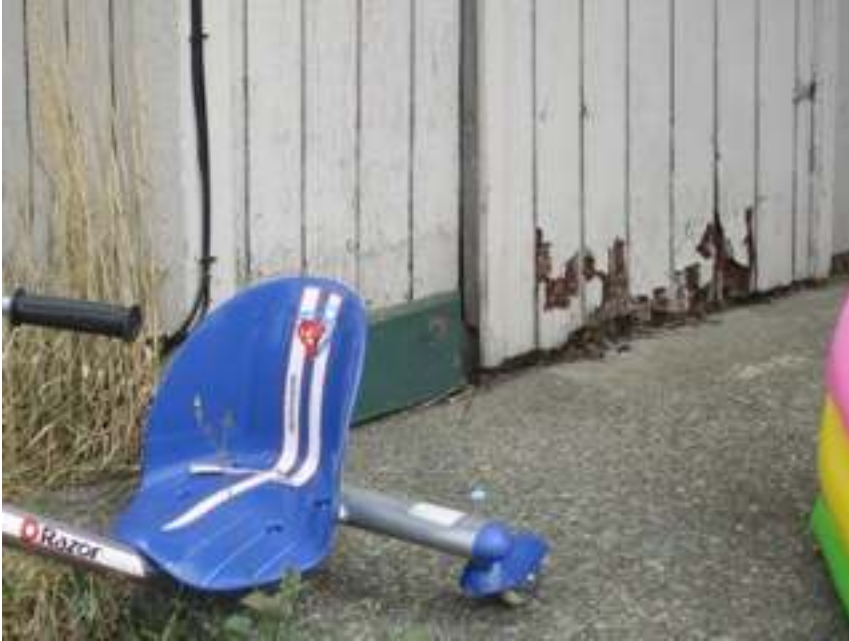
storage room door damage, typical at south facing, west side units

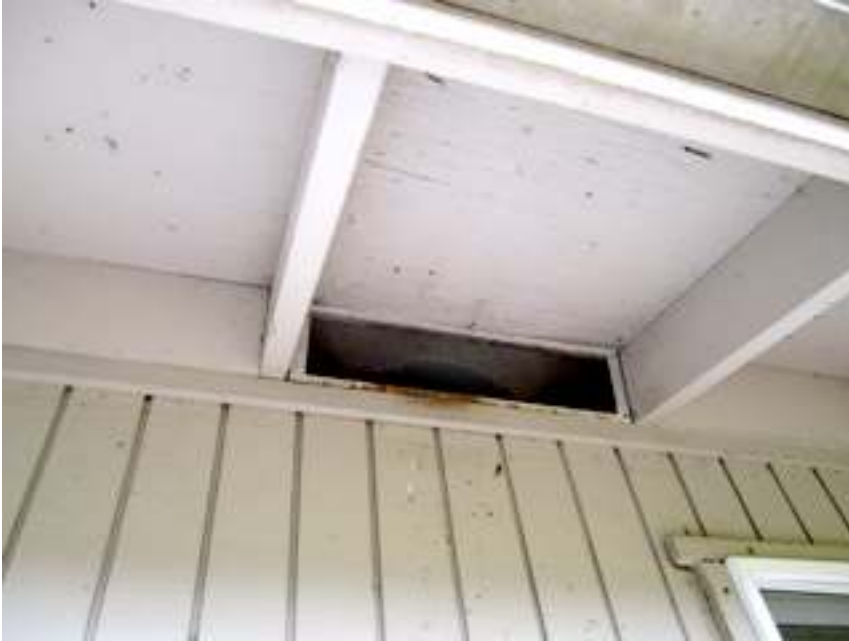
abandoned bath fan vent opening @ soffit

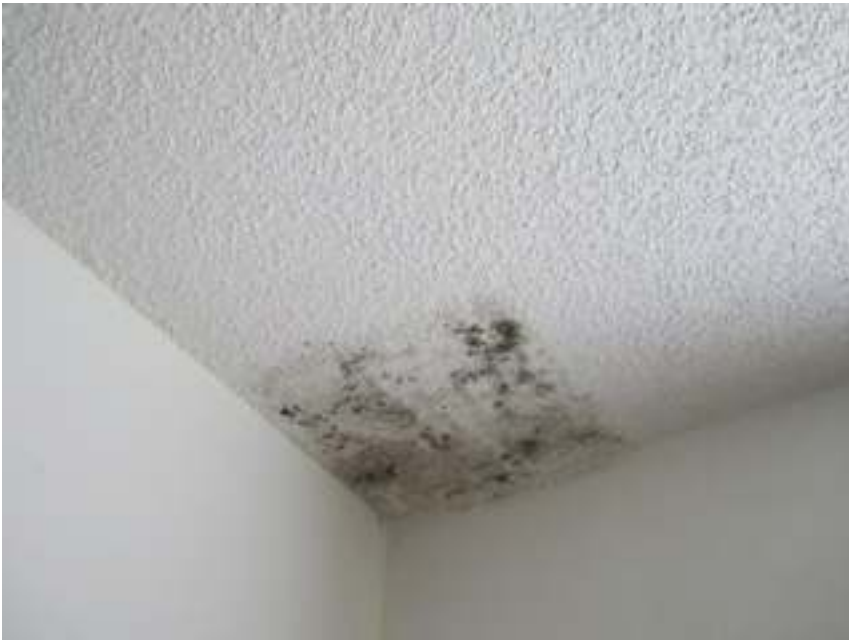
Many units were observed with water staining around the bathroom exhaust fans, on the ceiling drywall, with mold and water damage. A poorly or improperly vented fan will collect condensation above the fan housing leading to this type of damage.

typical ceiling staining @ previous bath fan exterior soffit vent opening

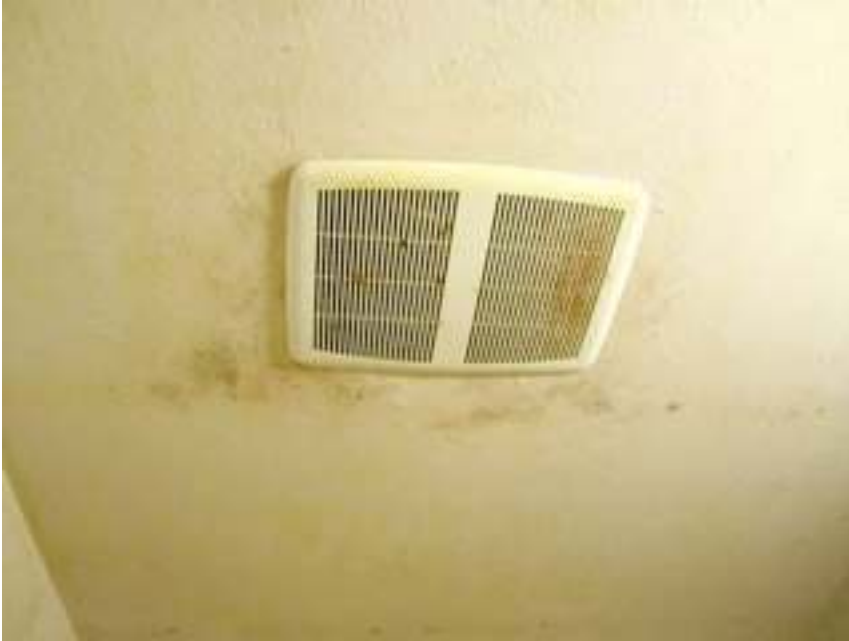
6.3.1.7. *note water damage & staining at many bathroom ceilings @ fan locations*

typical bath fan ceiling damage from condensate leaking due to improper ducting

6.3.1.6. *recommend replacing all of the attic ducting w/ code approved & installed materials*

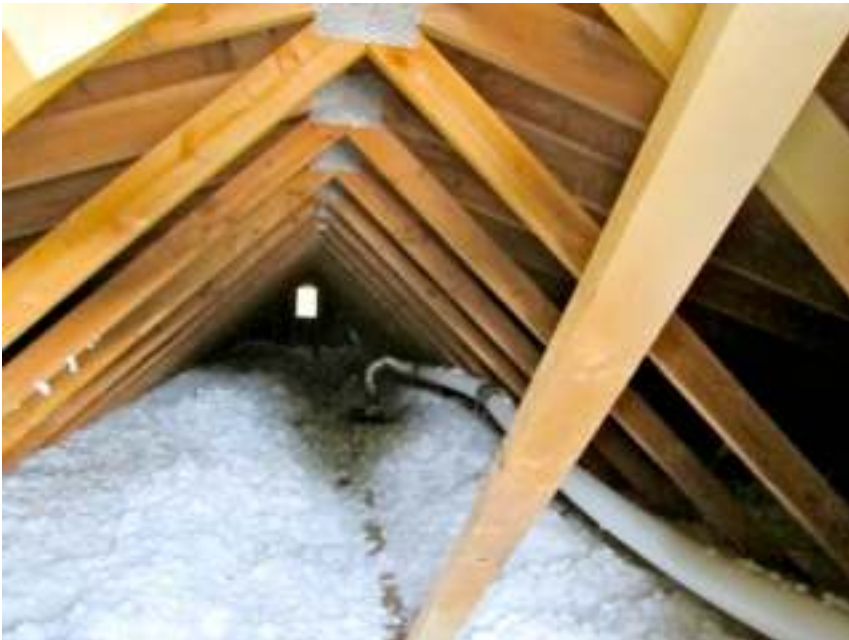
The bath fans have longer attic runs with improper ducting material that was poorly installed and failing in several locations. The code requires a smooth wall metal ducting material, sealed at the seams, sloped towards the exterior opening, and insulated to prevent condensation. The recent work employed poorly supported and improper PVC drainpipe as well as poor and failed flex transition from the fan housing to the horizontal run. In several locations, the PVC pipe has become disconnected or sloped creating a belly or a low spot collecting moisture. None of the ducting was insulated and all of the bath fan venting should be replaced to current code to prevent further water damage and mold problems.

6.3.1.2. missing required slope for condensate drainage

typical attic bath fan ducting poorly secured w/ low spots holding water

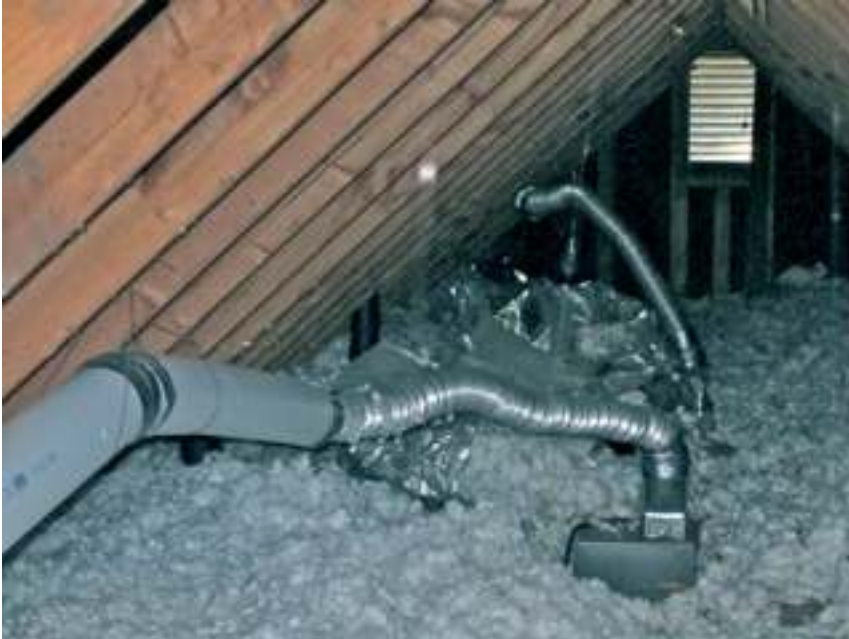
6.3.1.1. improper materials & missing insulation

typical poor fan to ducting transition w/ missing insulation

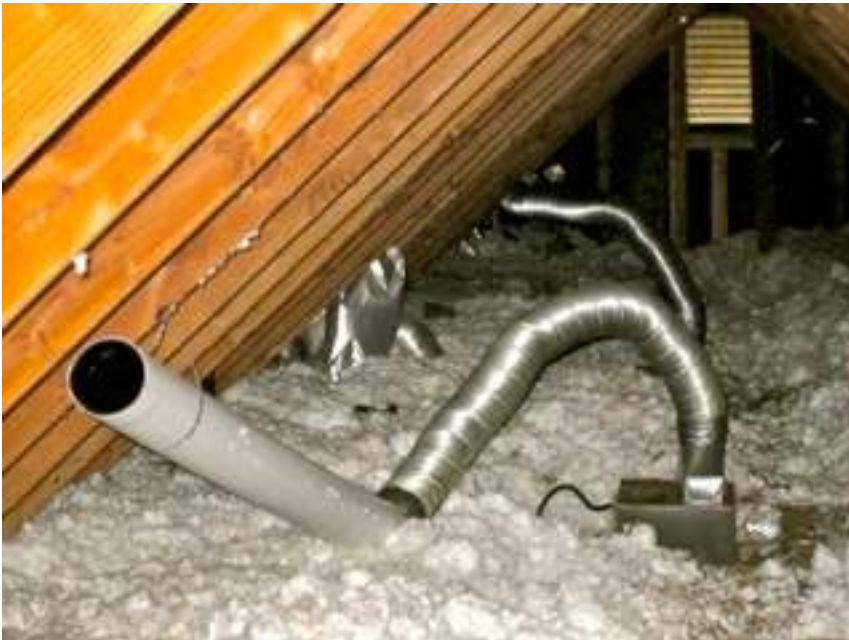
typical disconnected bath fan ducting w/ improper materials

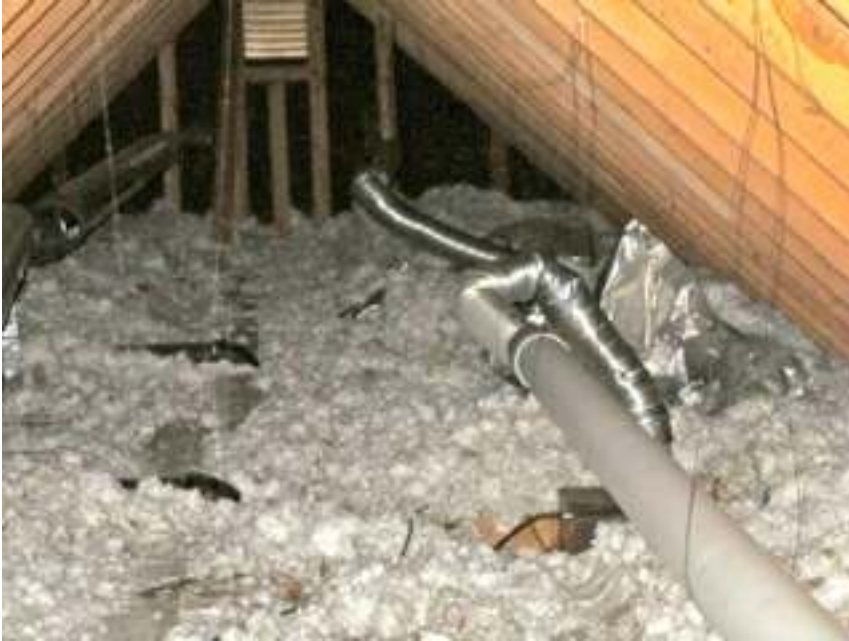
6.3.1. all units w/ improperly (recently upgraded) attic / exterior venting / ducting

typical bath fan ducting, not to code & poorly routed

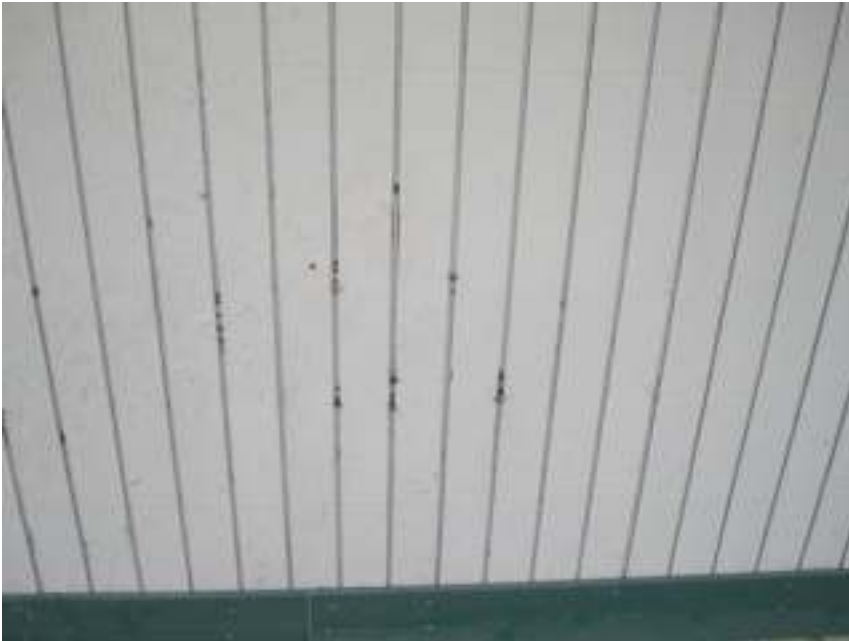
Unit 30, on the south side, has evidence of high moisture levels including a fungal growth on the T-1-11 siding and evidence of moisture damage to the interior drywall. Removal of the damaged drywall is recommended to determine the source and extent of damage as well as repairs. The source needs to be corrected prior to the re-installation of the drywall. Regular monitoring should follow proper cleaning of the exterior siding, a heavy paint priming prior to final paint coating.

Unit 30 south wall fungi growth

- 5.6.1.2. water / moisture source not determined
 - 5.6.1.3. *recommend removal of interior drywall to determine source of moisture & correct as needed*

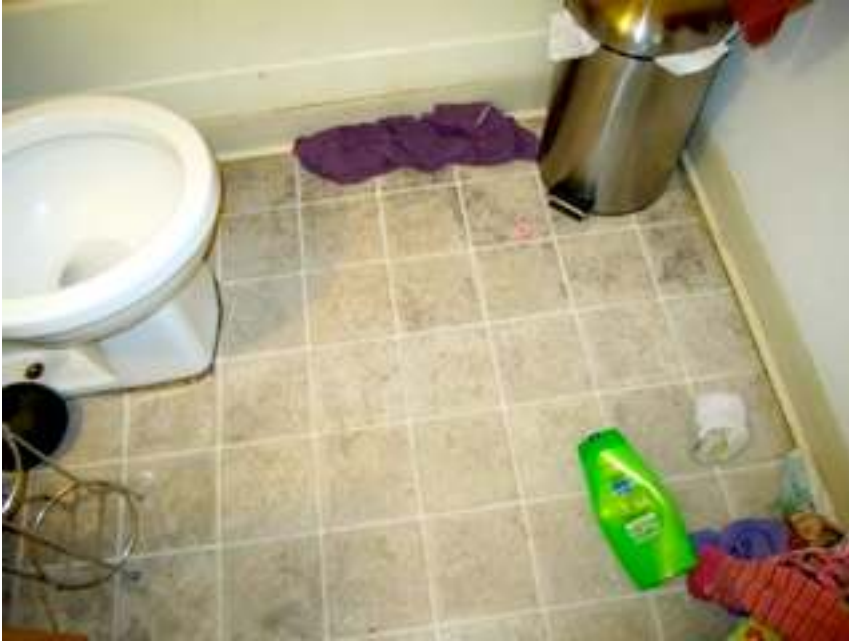
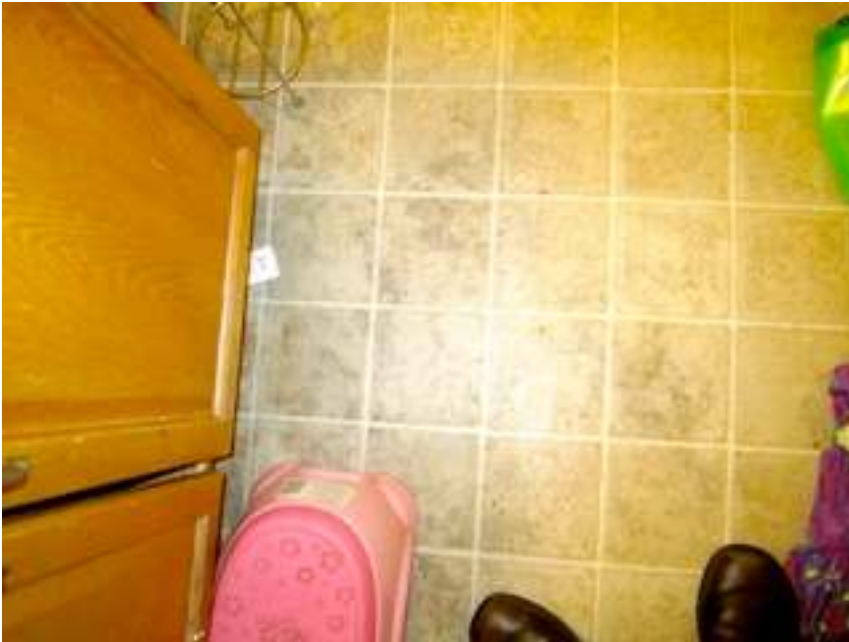
Unit 15 has evidence of high moisture levels under the concrete slab. The bathroom vinyl flooring has extensive staining from moisture in the slab and in the finished flooring. Potential sources for the moisture include a broken water supply pipe, a leak in a drainpipe, or water intrusion from the exterior roof drainage. Note this damage may have occurred due to prolonged water exposure and may not still be leaking. This home has evidence of extended high interior humidity with water stains on walls and ceilings.

A possible source, if slab still wet, is a damaged or broken tub or toilet drainpipe under the concrete. The water pipes enter the buildings under the slab, however they typically travel through the wall and ceiling framing to convey the water to the kitchen and bathrooms. The

manager recently observed the change out of the water meters and didn't have the impression that there were any water leaks from the supply side of this building. The bathroom is located away from the exterior wall and drainage, making this unlikely.

The toilet wax seal usually creates very localized staining, next to the toilet, as does a leaking tub drain fitting. Further analysis is recommended to determine if the moisture is ongoing and its source. A moisture test of the concrete slab, through the vinyl flooring should determine if this is a past event or an ongoing problem. A sewer inspection may be helpful if the slab is still wet. A camera view of the pipe interior, maybe helpful if the break is in the larger main drainpipe from the toilet. However the shower drain isn't accessible by a camera due to the p-trap directly below the tub as well as the smaller diameter pipe. The repairs typically require opening the concrete flooring to access the pipes and then patched after the work is complete. The flooring will need replacement due to the moisture damage and if opening of the slab is required.

Unit 15 w/ moisture damage to bathroom flooring

1. **Unit 15 bath floor:**
 - 1.1. high moisture levels observed
 - 1.1.1. vinyl staining throughout
 - 1.1.2. *recommend moisture meter testing of concrete slab below / through vinyl*
2. **Sewer system:**
 - 2.1. unusual sewer / septic system observed
 - 2.2. *recommend obtaining additional information regarding system design & owner responsibility for repairs and maintenance*

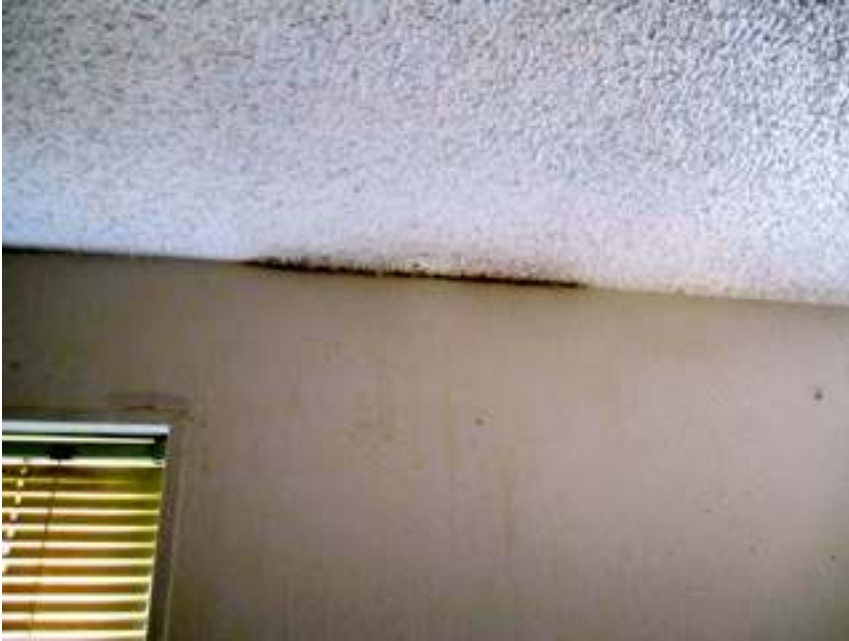
- 21.1. evidence of very high interior moisture levels
 - 21.1.1. heavy water staining on walls & ceilings
 - 21.1.2. bathroom floor w/ heavy water stains in vinyl flooring
 - 21.1.3. mold growth on living room & NW bedroom ceilings
 - 21.1.4. heavy moisture damage @ bathroom ceiling fan
 - 21.1.5. *appears to have had a long term hot water leak to produce steam for extensive water staining*
- 21.2. strong odors: cat, dog & smoking
- 21.3. exterior patio door missing weather stripping

Unit 15 w/ evidence of previous very high interior moisture levels
note water staining / drips on walls were observed throughout unit

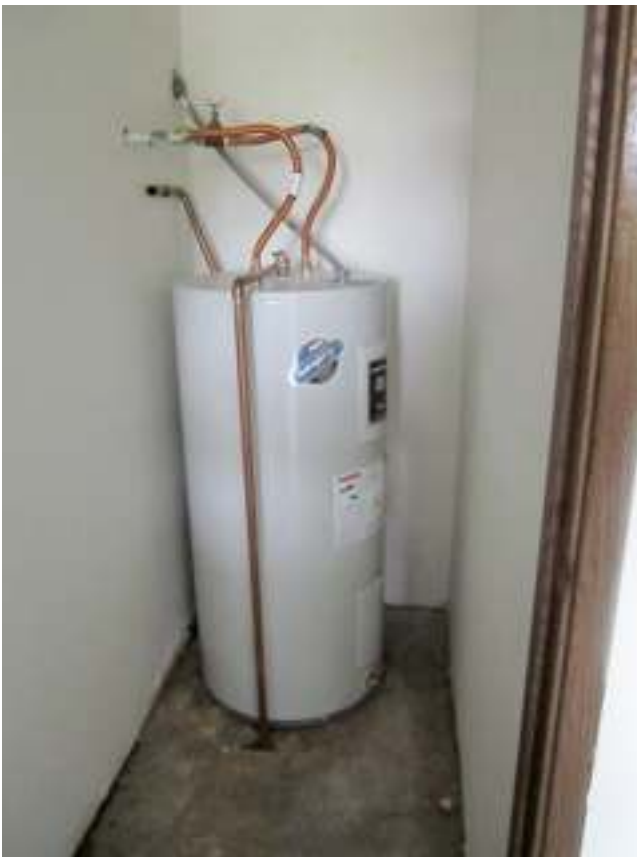
Water heaters are an ongoing replacement issue that comes with any residential structure. However, none of the electric 50-gallon water heaters have been installed to meet the codes at the time of installation or current codes. Current requirements include seismic strapping, at two locations on the tank, a thermal insulation / isolation pad (when placed on an a concrete pad), and piping on the PTR (pressure temperature relief) valve to drain down hill to the exterior.

6.2.1. all observed electric water heaters not installed to code

6.2.1.1. missing code required seismic strapping (2), insulation pad under tanks, and several units w/ missing or improper PTRV drain pipes

typical water heater installation, not to code

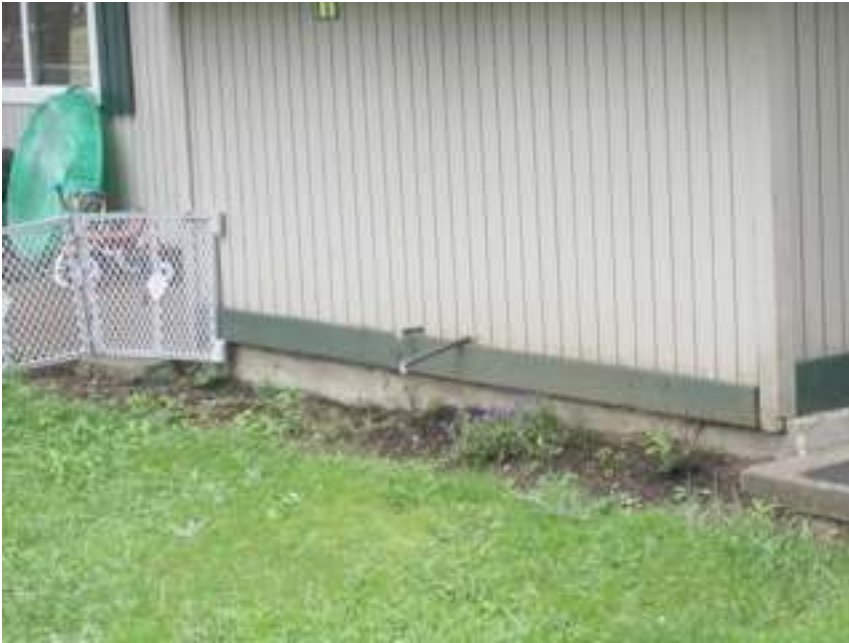
No water heaters were observed with the required strapping or pads. Several were observed without the PTRV piping, two of the water heaters, Units 33 & 34, have excessive piping exposed at the exterior, susceptible to damage from pedestrians and lawn mowers. Unit 8 has evidence of a failed PTRV with water dripping from the exterior drainpipe.

Unit 33/34 water heater PTRV's extended

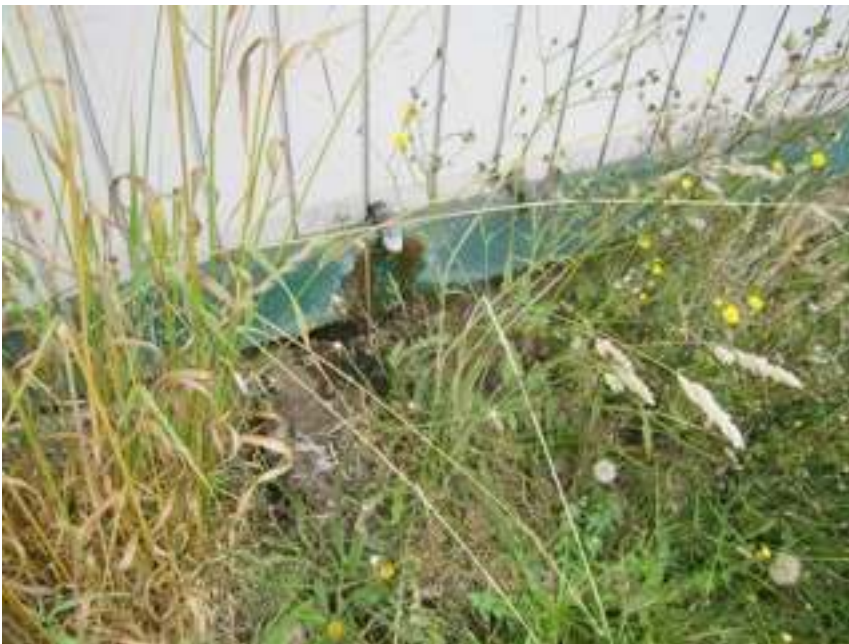
6.2.2. active tank PTRV leaking observed in unit 8

Unit 8 water heater PTRV leak

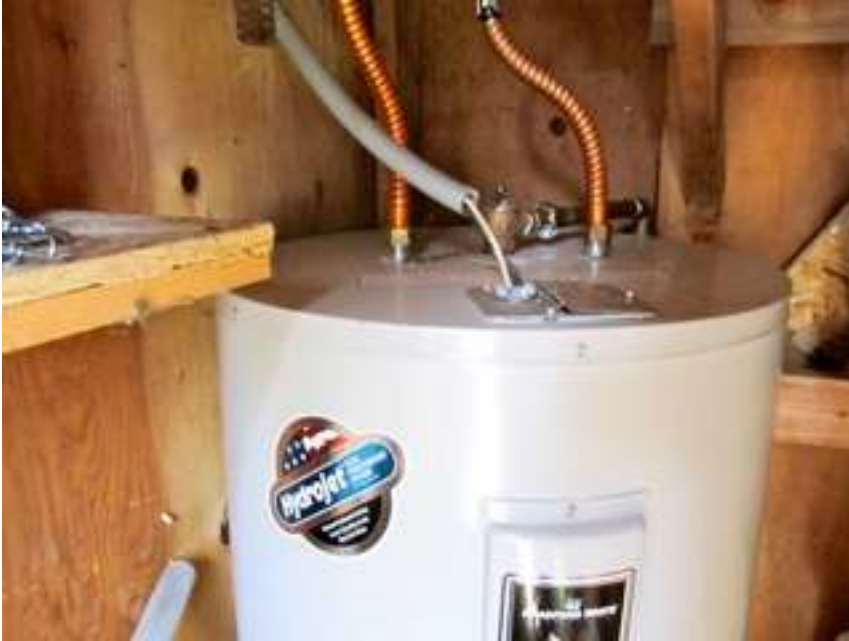
6.2.3. unsafe electrical connections

6.2.3.1. several observed w/ exposed wire connections

Unit 32 water heater w/ exposed wires

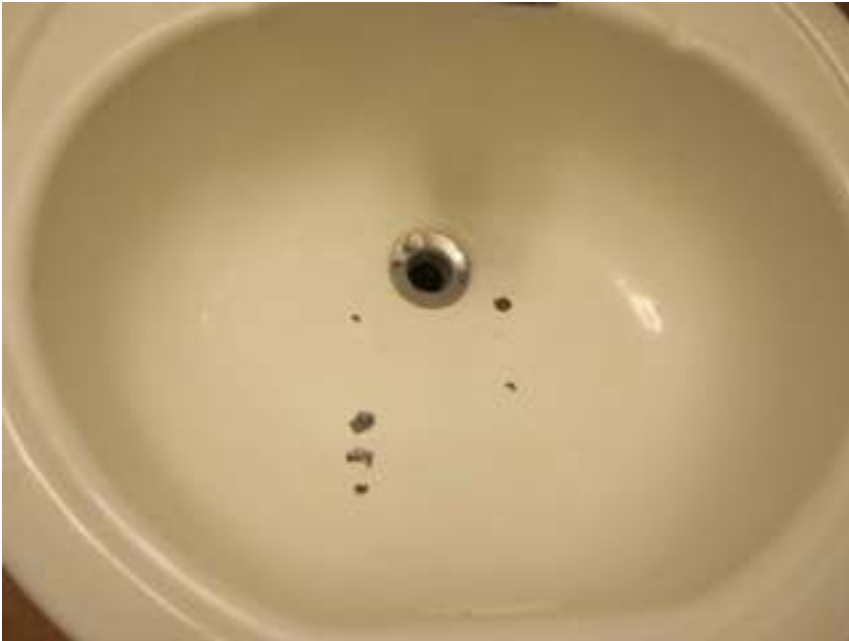
Plumbing repairs are needed to several of the homes and are listed in the Unit interior section. The original bathroom sinks are steel and many are still in service, these units' rust and chip creating leaks below the sinks. As the bathrooms are upgraded, sink replacement is needed.

typical steel bath sink failure

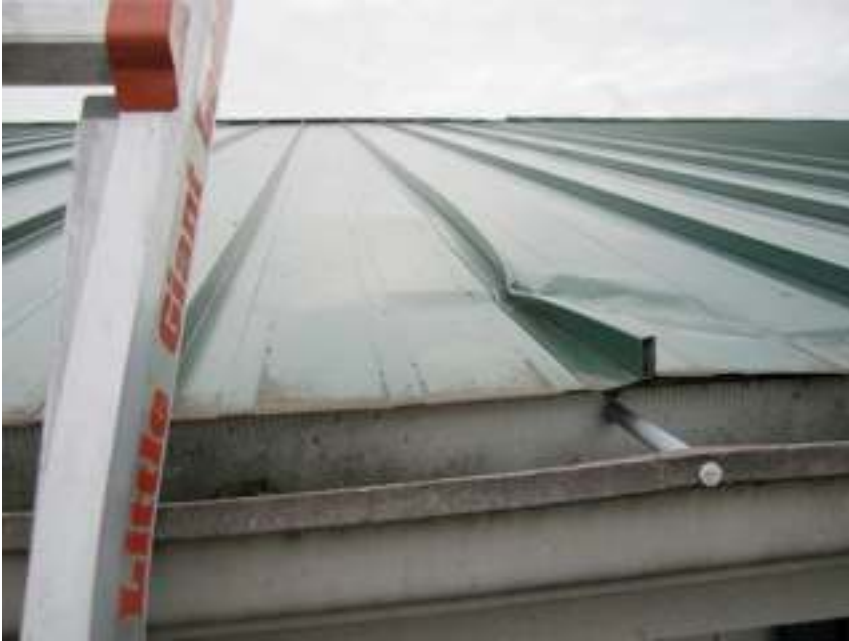
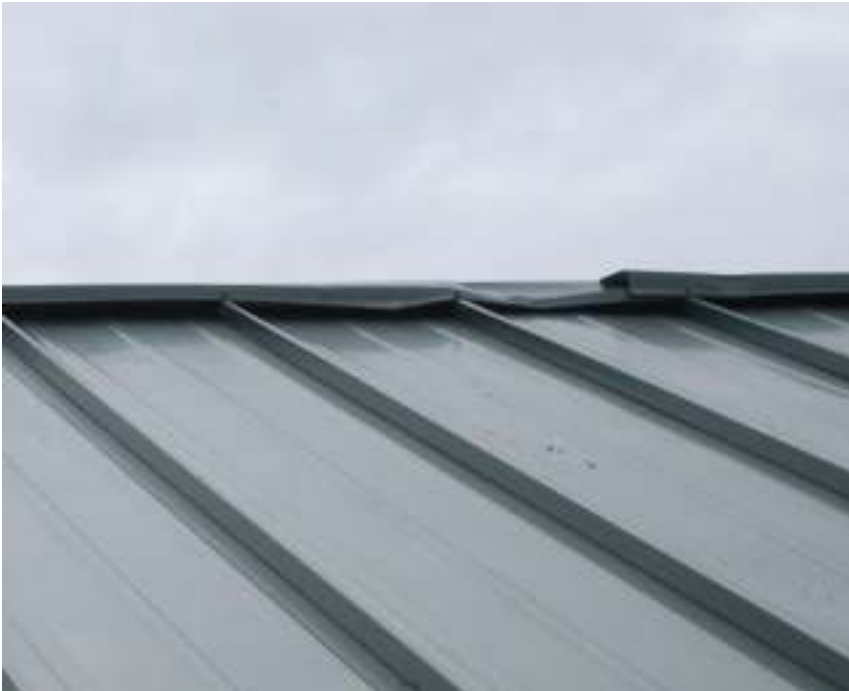
Building 7/8 appears to have had a tree branch fall on the roof causing minor damage. One rafter tail, on the east side, is broken and causes not structural issues or concerns. The roofing panels show minor scarring from the impact and the ridge vent flashing is bent. No current repairs are needed.

Unit 7/8 roof damage

Unit 7/8 roof damage @ ridge
