Home and Building Services, inc.

Consult Focus: Commercial Space, General Conditions

Consult Date: October 7th, 20XX

Consult Address: ##### NW ## Street
Seattle, WA 98117

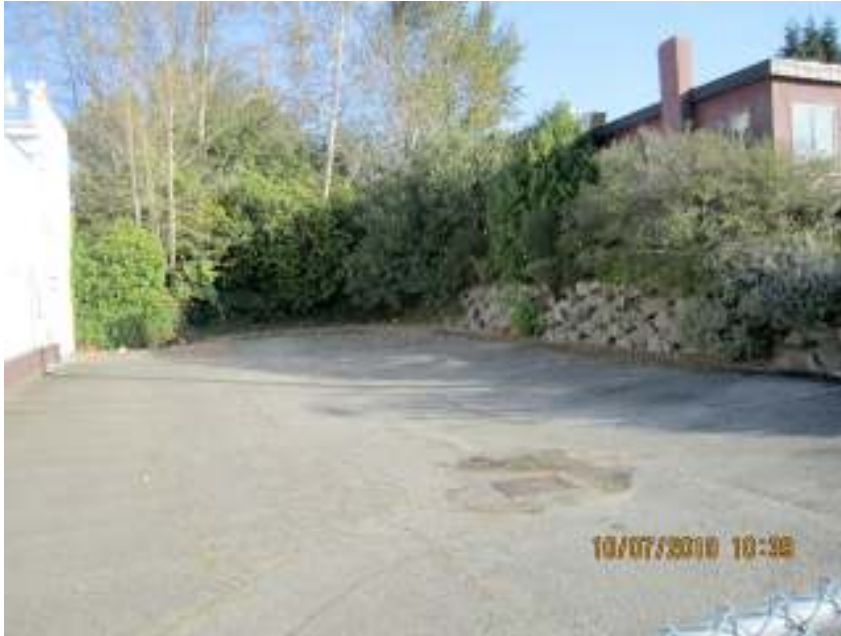
- parking asphalt lot w/ settling @ catch basin & typical patching
 - appears sufficient for continued use
 - recommend installing sealing coat & new parking stripping

asphalt parking lot & catch basin

- parking: asphalt lot; install asphalt seal coat & new parking stripping
- landscaping:
 - correct all high soil levels above building foundation & maintain
 - remove all ivy from exterior cladding & maintain
- siding / stucco:
 - remove all damaged material @ interior NW & NE corners of building
 - replace all damaged & decayed material
 - provide permanent protection from future soil contact
- doors: - replace exterior NE corner garage man door
 - replace both front / south entry doors

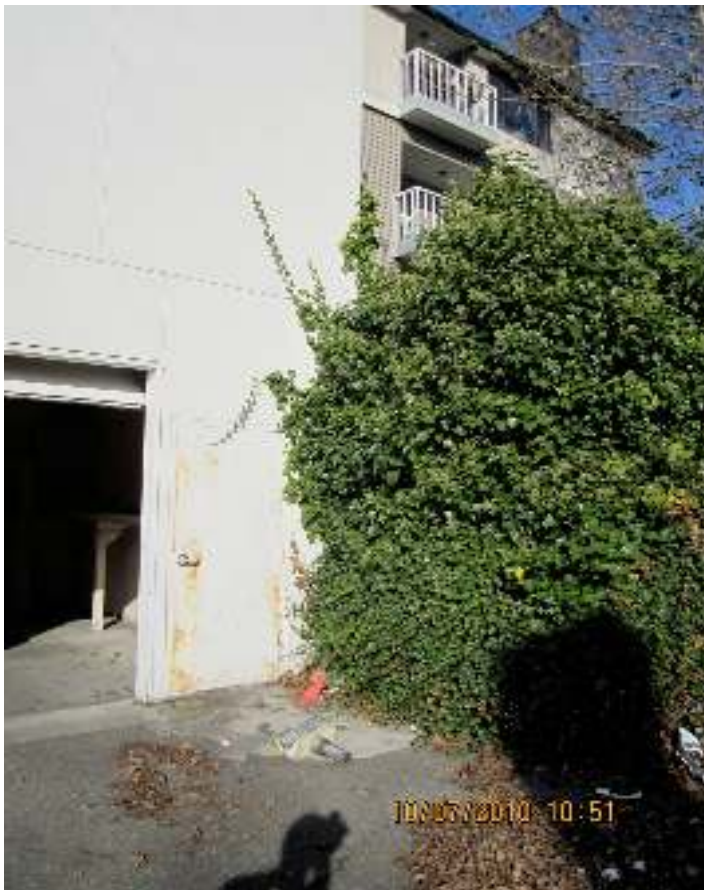
- landscaping minimal
 - high soil levels @ north side w/ water intrusion & damage @ NW & NE corners of building
 - ivy growing on stucco exterior cladding @ NE corner; remove to inspect & maintain

soil & ivy contact w/ exterior cladding damage

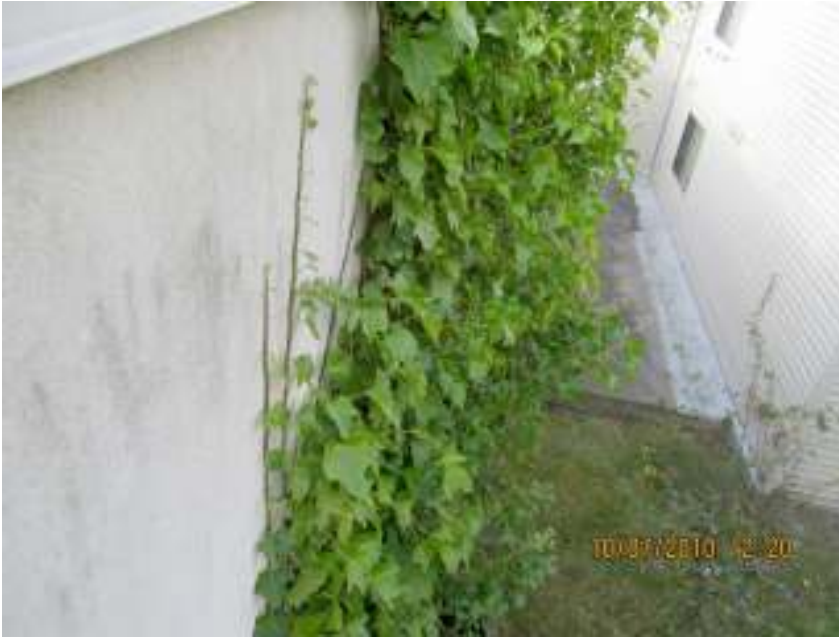
north wall ivy growth

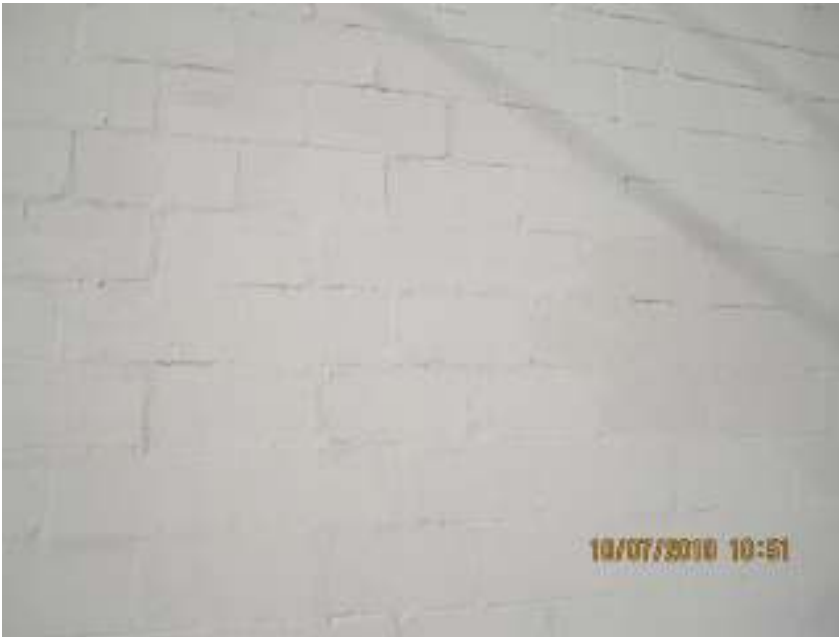
- rock retaining walls appear stable, where visible w/ heavy ivy growth
- exterior cladding
 - CMU, cinder block exterior walls w/ evidence of previous patching & repairs @ east side, typical

CMU repairs, typical

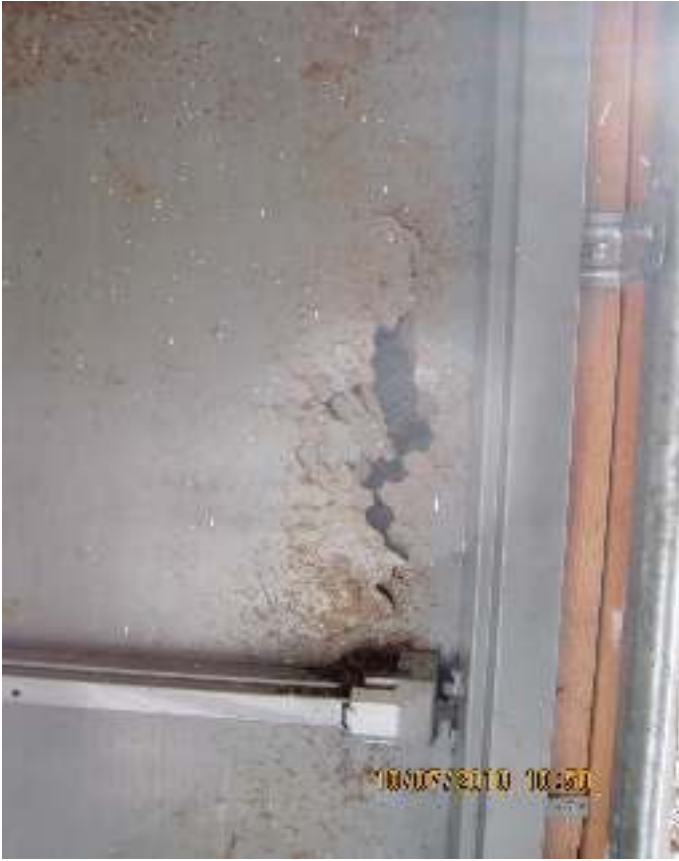
- recent light / cosmetic paint applied to exterior, no evidence of masonry / stucco rating; short expected life span
- doors
 - failed rusted exterior NE corner garage man door; needs replacement

failed / rusted NE corner garage door

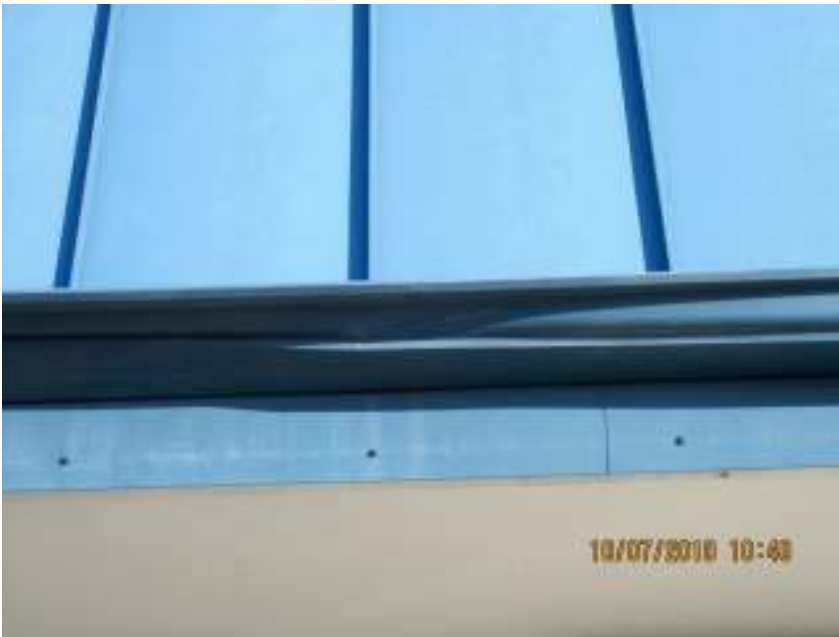
damaged gutters on south side

- roof membrane:
 - replace all temporary patching w/ permanent repairs
 - renew reflective coating
 - reseal & maintain poorly installed roof edge / parapet wall cap flashing
- drainage:
 - have a sewer pipe camera inspection to determine drain connections & correct as needed
 - install additional drain for overflow purposes
 - improve roof drain installation (in wall cavity) to protect against moisture in the wall & heat loss from the interior
 - cosmetic repair to bent front / south aluminum gutters

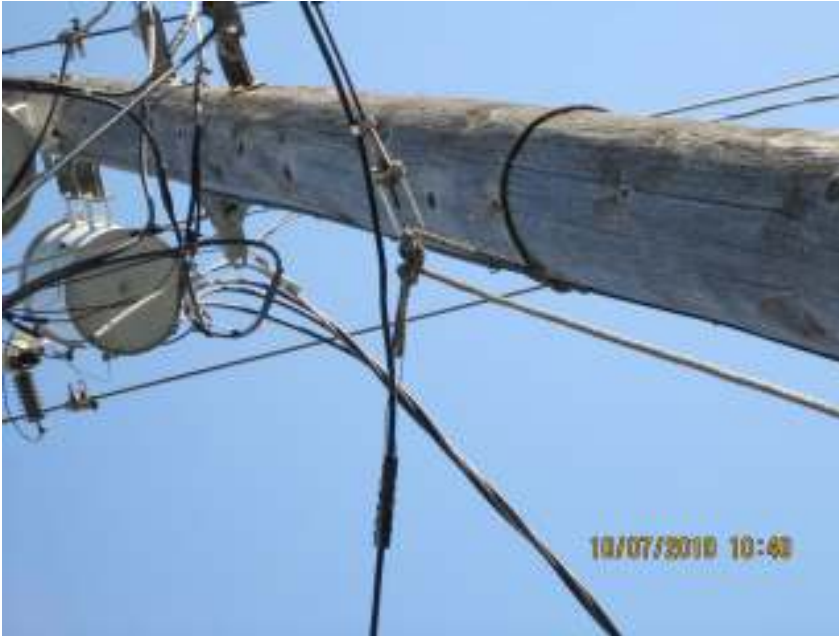
telephone wiring w/ temporary rope mounting

- remove / replace all remaining original knob & tube wiring
- repair / correct unsafe exposed electrical wires on roof
- correct phone service wiring from street / power pole into building
- install new smoke detectors to current code & standards

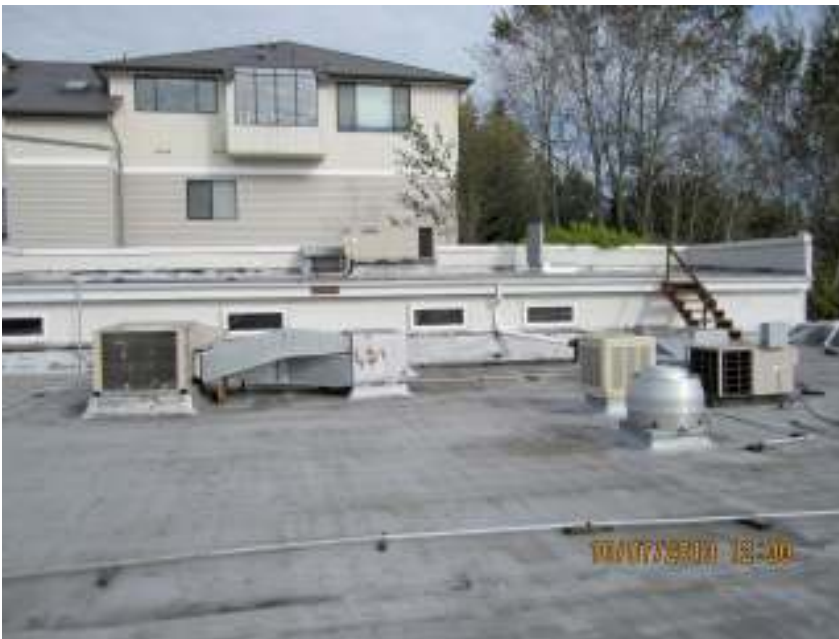
Mechanical air handling equipment, located on the roof, is nearing the end of its economic life span. This equipment all appears to have been installed in 1996 with minimal evidence of maintenance or regular servicing. A licensed and qualified HVAC contractor should determine its current serviceability as well as their remaining life span of the equipment. It should also be noted that the installation and materials do not reflect today's standards for air sealing and insulation of exterior exposed ducting, creating an inefficient system for heating and cooling with today's energy costs.

- York Heat Pumps, roof mounted
 - near / at end of economic life spans, 15 years old
 - no evidence of regular maintenance or servicing
 - poorly sealed & insulated roof top exterior exposed ducting

roof mounted HVAC equipment

- full inspection, testing & listing of needed improvements to the heat pump system
- locate main water shut off valve, water meter & entry point
- interior water pipes need replacement
- replace garage water heater
- clean & service 2 roof mounted commercial exhaust fans
- inspect wet room exhaust fan & venting; improve / correct / repair as needed, note recommend opening ceiling @ fan & vent path to determine extent of corrosion & moisture damage

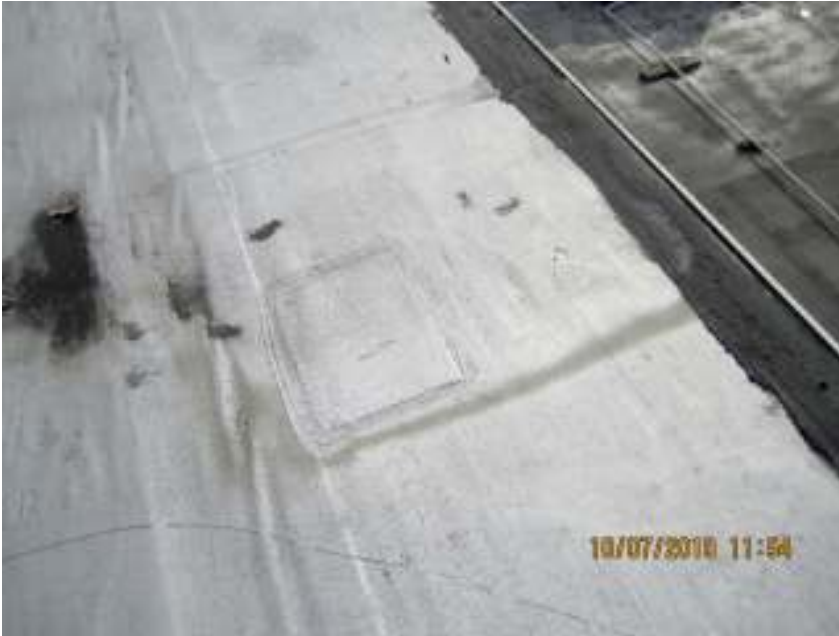
The roofing material is a torch down membrane. It has evidence of ageing with cracking in the surface as well as patching. The roof appears to be approximately fifteen years old and will require replacement within the next ten years. Drainage issues and problems were identified and need to be addressed prior to replacement to provide for overflow requirements.

torch down roof patching & cracking

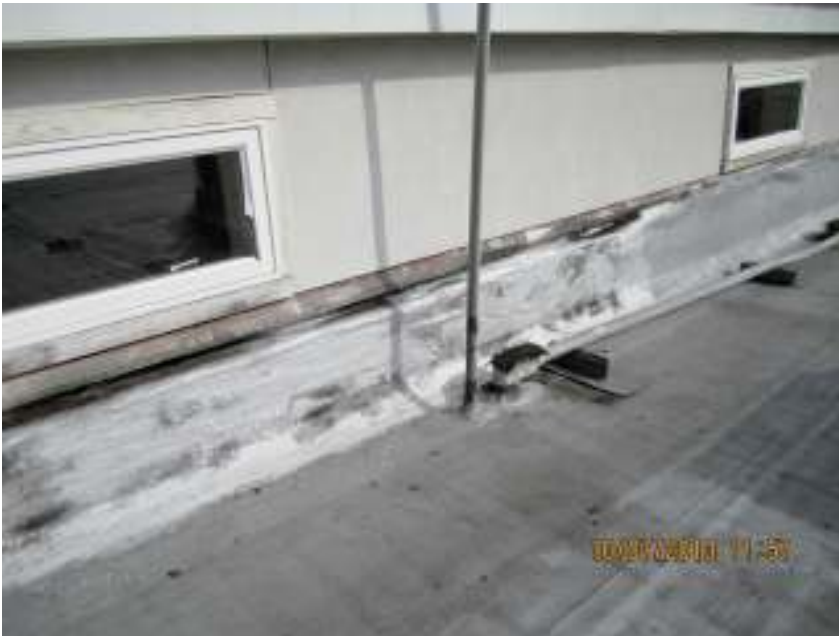
temporary roof repairs @ single drain opening

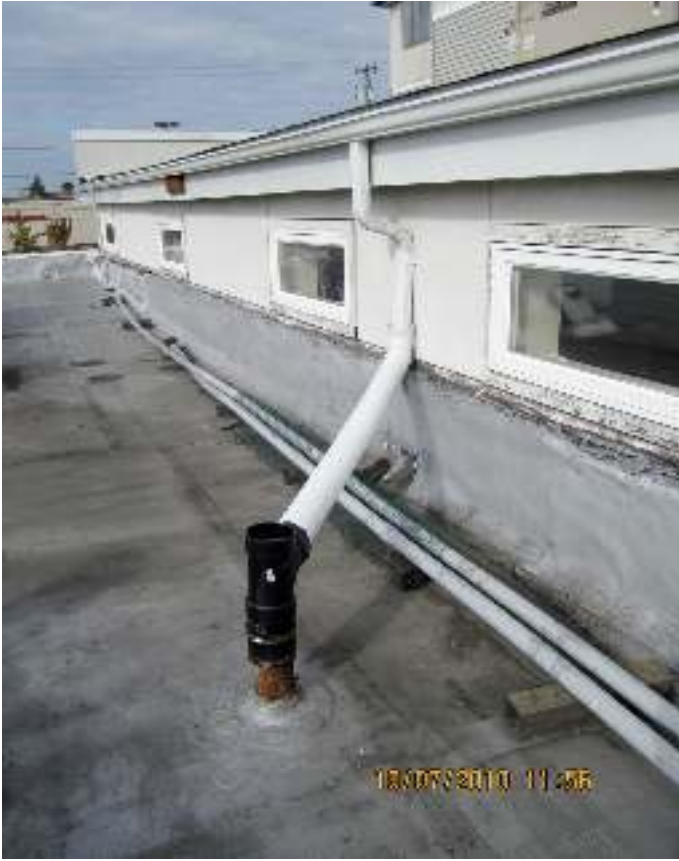
The drainage issues also include the appearance of the roof drainage connection to the sanitary system. Although this was a common practice at the time of original construction, currently changes are needed to separate the storm water from the sanitary sewer connection. Recently the upper roof drainage was diverted into a pipe that appears to be the sanitary drain vent pipe. This likely condition does not meet code and may cause problems with the sanitary drain system servicing the bathrooms and wet room. It should be noted that the roof drainage requirement to drain into the storm system was in place at the time of the addition. Further analysis is recommended to determine the current sanitary and storm system drainage. An independent camera survey is recommended.

improper upper roof drain connection

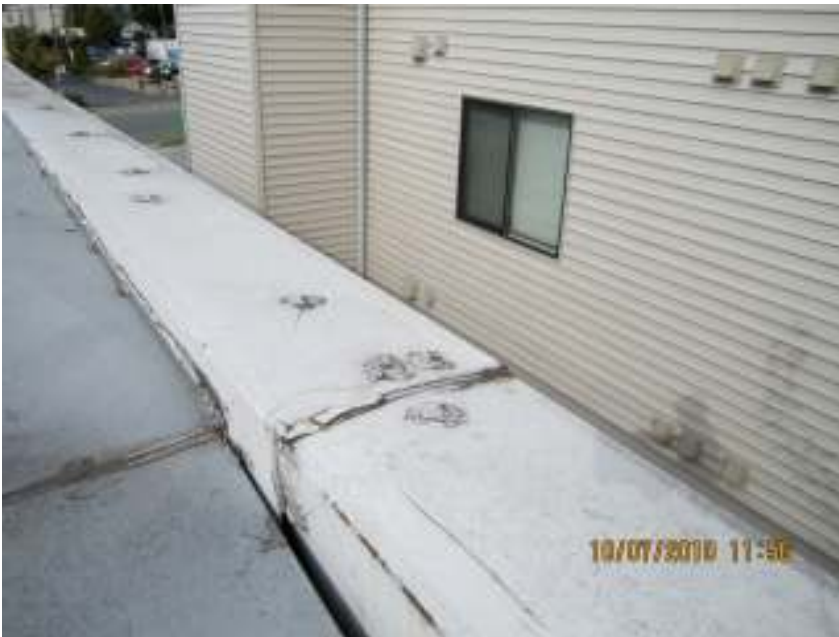
parapet wall cap flashing w/ poor / failing seals

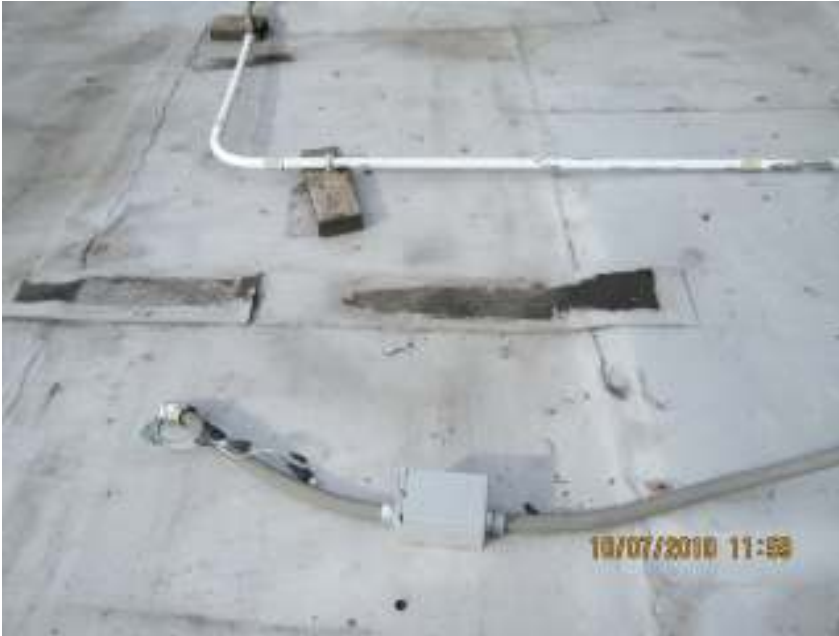
exposed electrical wiring

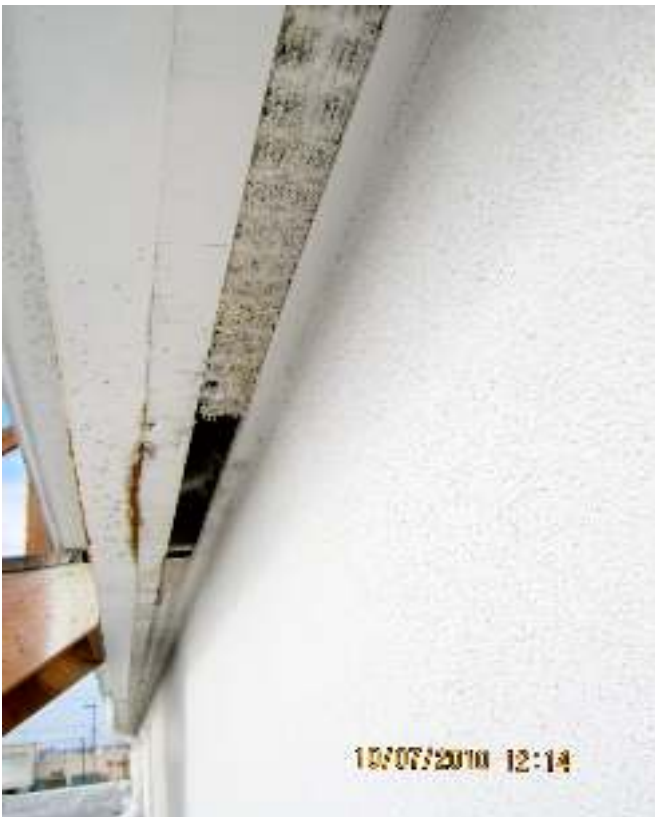
The upper east room, with the plumbing connections, sinks and filter connections, has been poorly vented through a framed roof cavity. Corrosion was observed at the upper level exterior roof soffit venting. The overhang has a screened opening, intended for venting the roof cavity, that appears to have been used improperly for the ceiling fan exhaust. I recommend opening up this section of dry walled ceiling to inspect the framed cavity, insulation and roof sheathing condition. The extent of damage to the aluminum screen suggests potential moisture and / or chemical damage to this area. This fan should be vented directly through the roof to provide proper air movement as well as limit the roof framing damage caused by improper venting.

upper roof soffit corrosion, possible fan exhaust

- upper level wet room ceiling exhaust fan w/ corrosion / damage to exterior
roof soffit vent screen, cause & condition not determined; recommend
opening ceiling @ fan & trace exhaust ducting run to exterior
 - o note fan should be vented vertically to exterior, not horizontally,
due to length of run w/ moisture / condensation concerns

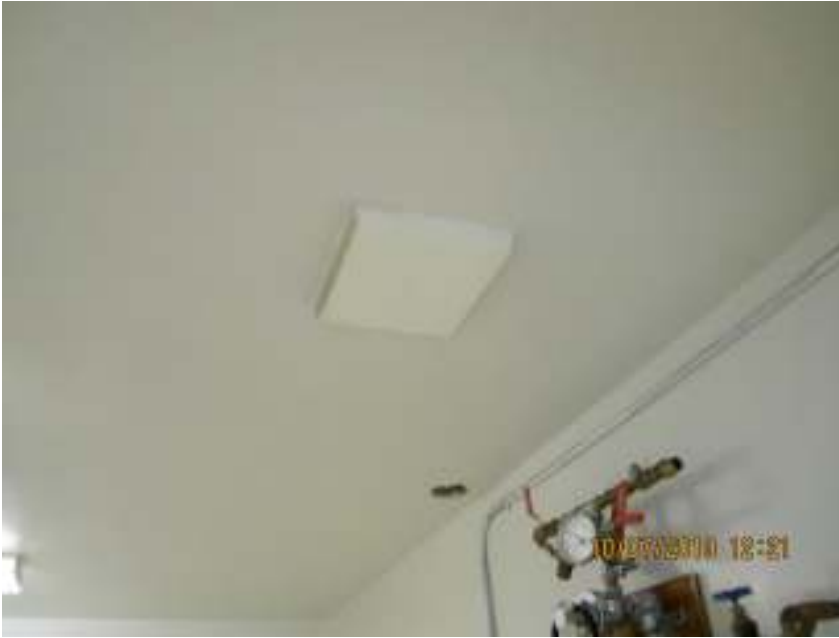
- exhaust fans: 2 commercial units observed on roof
- exhaust fan: 1 residential quality unit observed in upper level wet room; not properly vented to exterior w/ corrosion & damage near soffit opening

upper wet room exhaust fan w/ improper exterior venting

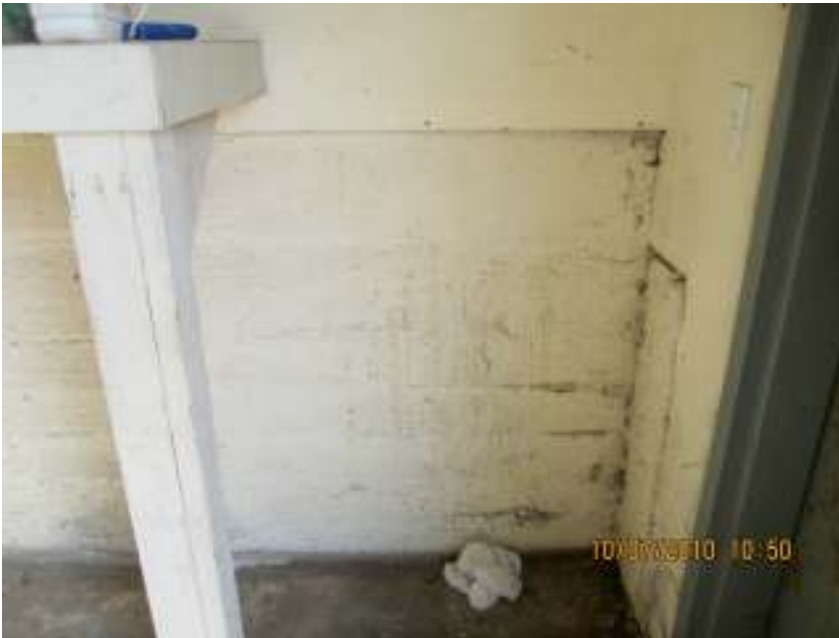
- water damage & soil contact @ NE & NW corners of building w/ ant frac
 - evidence of water intrusion along north foundation wall w/ previous water proof sealant applications

water intrusion @ NE corner

Structural: - moisture / water damage to exterior walls @ NE & NW corners of building
recommend removal of all damaged material for further inspection of
structural wall framing & extent of damage / mold

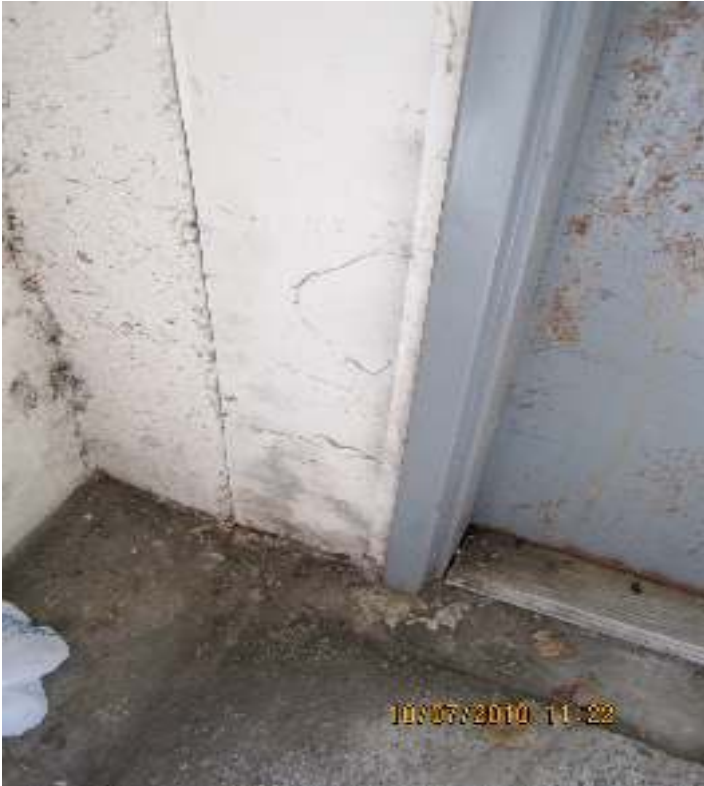
The wood framing has damage due to soil contact in two locations. The interior drywall finish exhibits this water damage with mold growth and the presence of ant frace, typical for carpenter ant infestations. A destructive inspection will be necessary to determine the extent of the damage and the needed repairs. These areas are at the NW and the NE corners of the buildings addition. Removal of the damaged interior drywall will allow views to determine the extent of the water damage to the structural framing as well as the extent of the mold growth. I am available to perform this additional inspection if the buildings owner grants permission, to open these areas that currently require repairs.

NE corner water damage & mold

- floors: - test floor tiles & adhesives for potential asbestos content
- walls: - repair water staining & damage @ common wall / door w/ addition
 - remove drywall for further inspection & correction @ water damaged areas in NW corner closet & NE corner; note all water damaged materials need to be removed
- ceilings: - upgrade all ceiling insulation when tenant improvements are complete
- stairs: - repair loose hand railing @ north wall & replace section @ south wall

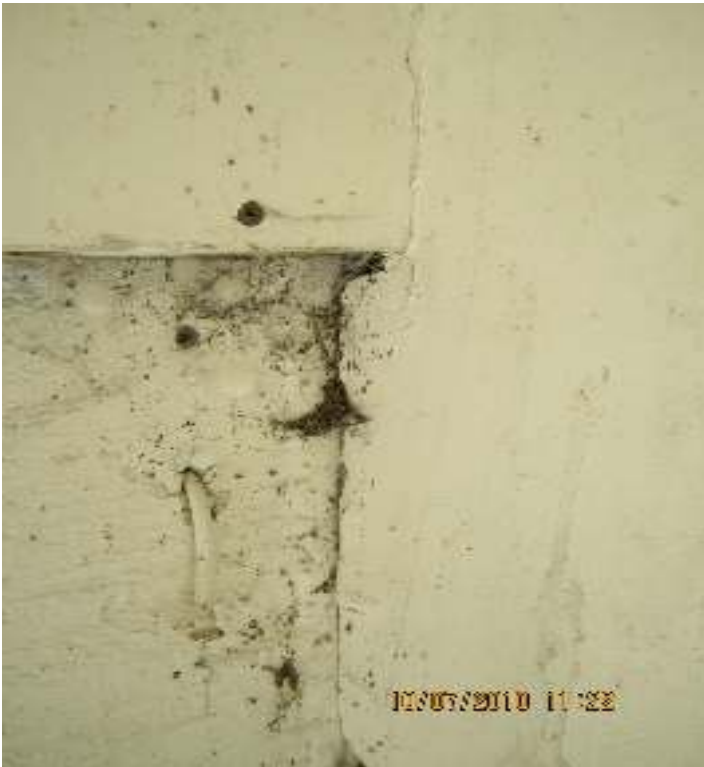
NE corner damage & ant trace

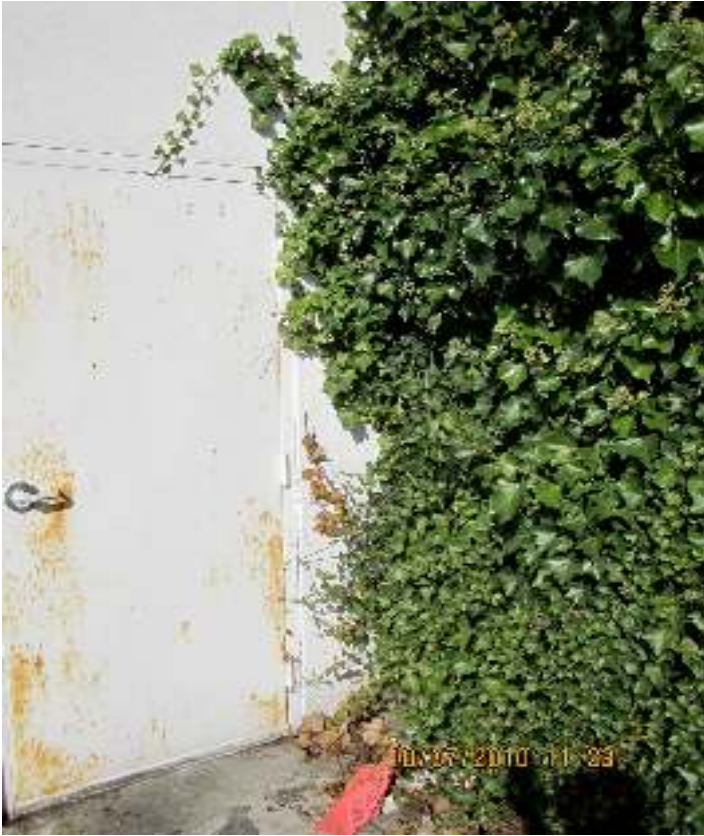
NE corner soil & ivy contact @ damage

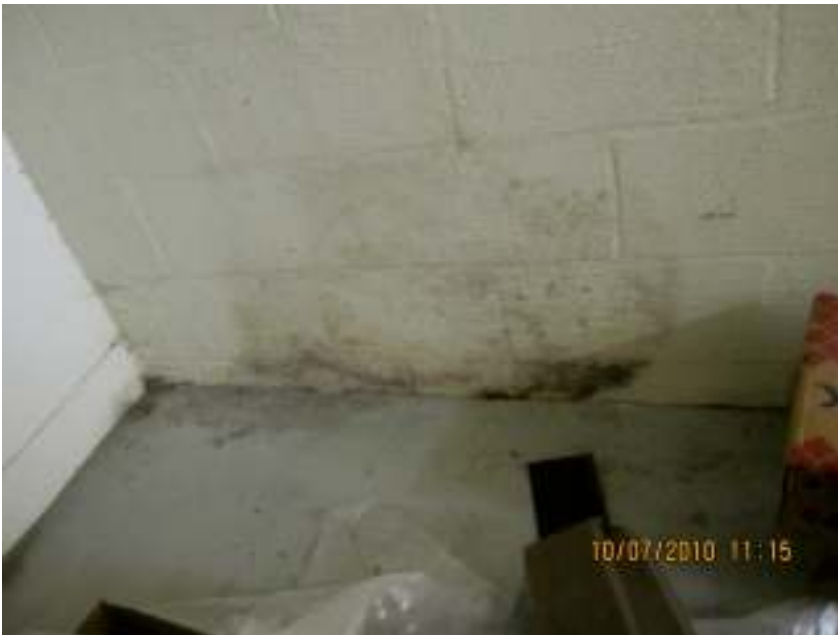
- below roof drain @ addition wall / garage man door
- SW corner, minor ceiling staining
- NW corner closet, under stairs of addition, drywall damage & mold needs further inspection
- NE corner @ failed / rust exterior man door, high soil levels & contact w/ wood framed wall; drywall damage & mold needs further inspection
- north wall foundation w/ evidence of intrusion & previous water proofing attempts

NW corner water & mold damage

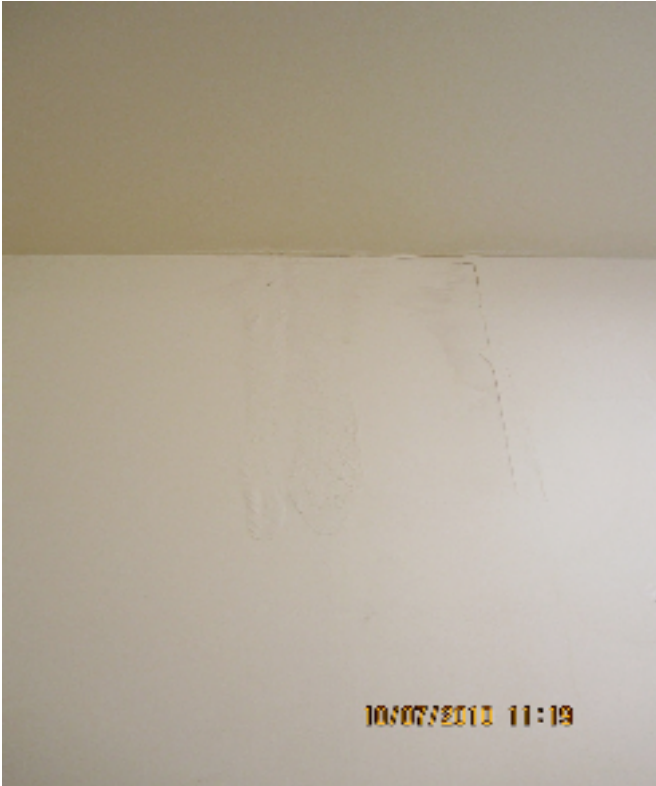
water damage below addition roof to wall intersection

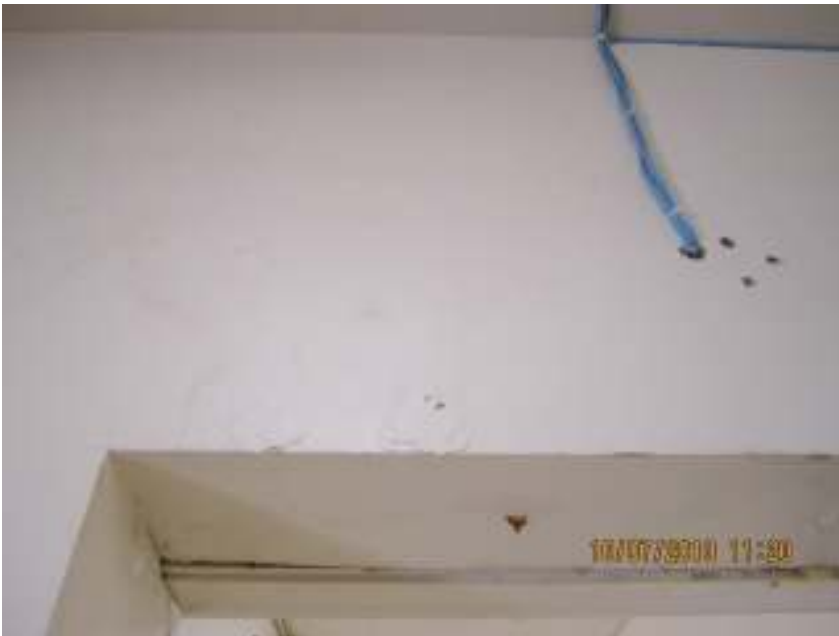
water damage below roof drain

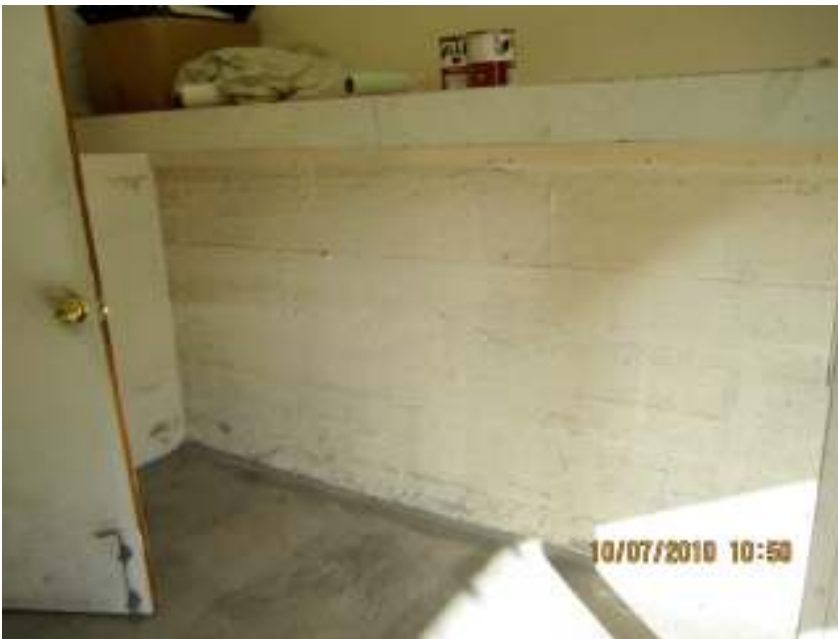
north wall water staining

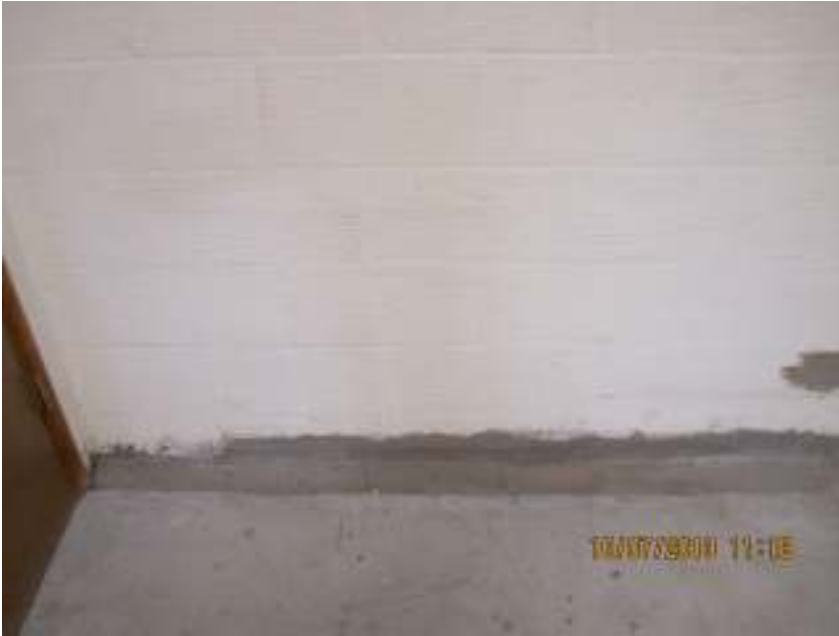
typical north wall water proofing

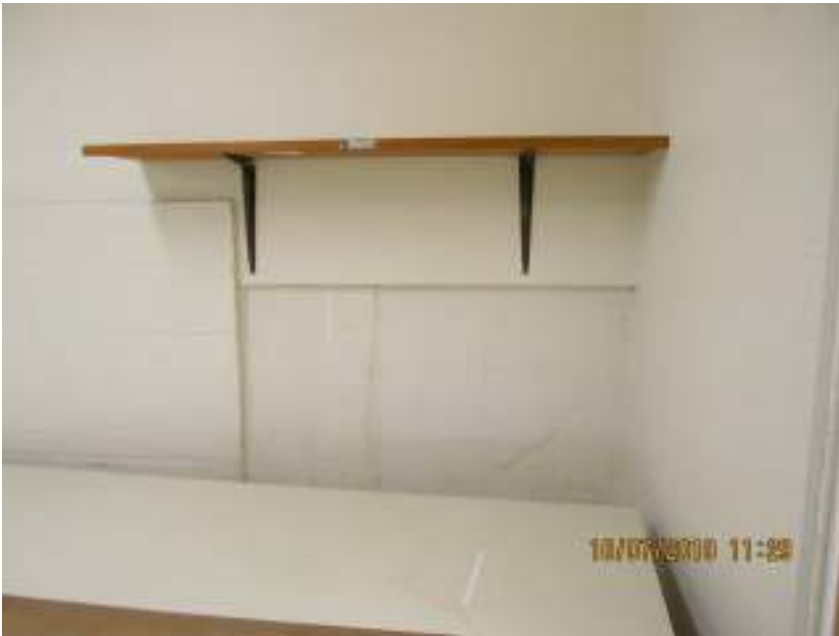
The addition appears to have incorporated an original CMU retaining wall, along the north side lot line, supporting the slopes at the north side of the property. The western end, as well as the eastern portion, are a poured in place concrete retaining wall / foundation wall. The foundation for the 1996 addition includes both types of construction and the seams, referred to as cold joints, can be susceptible to leaking.

typical north wall water staining & foundation transition

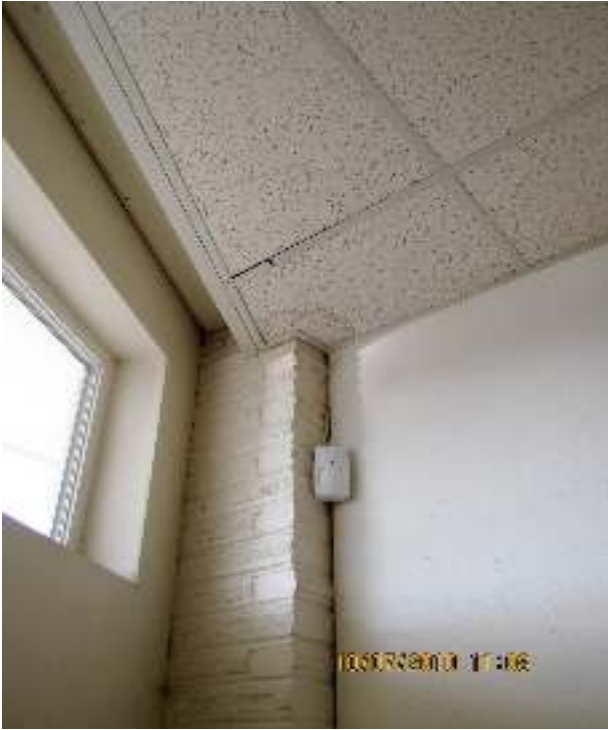
minor water damage @ SW corner

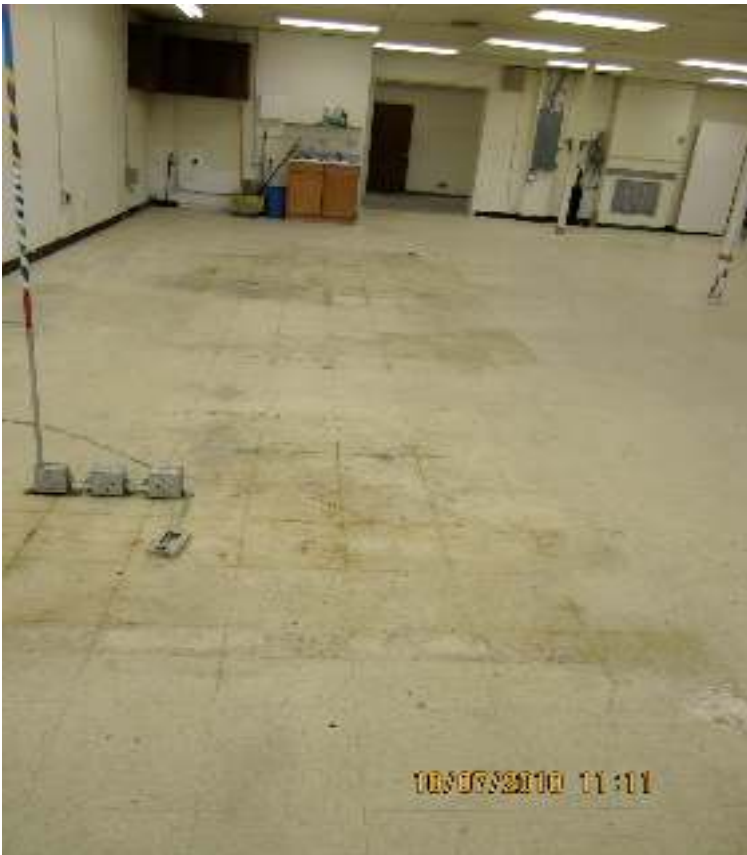
typical floor staining

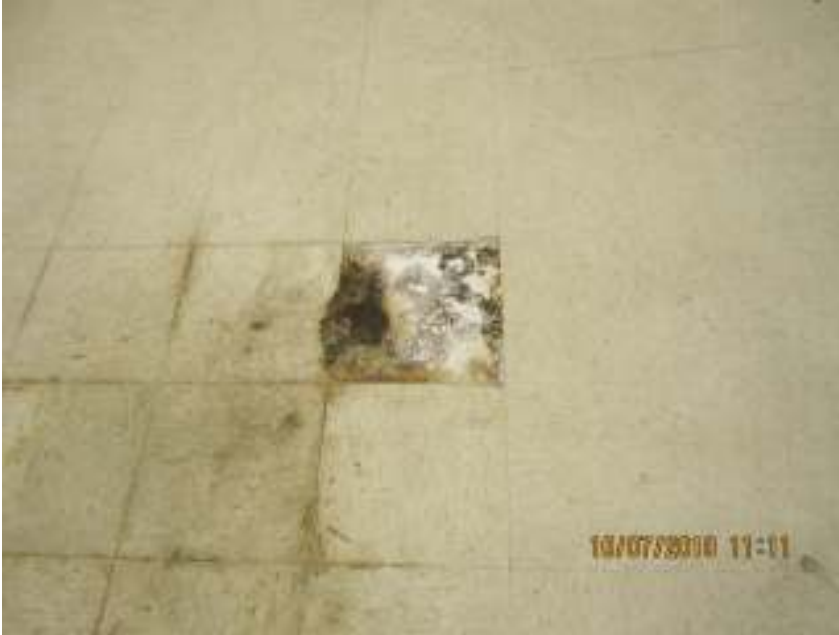
- floors:
- concrete slab on grade floor w/ multiple layers of linoleum floor tiles
note, older tiles & adhesives typically contain asbestos fibers that pose no risk with normal wear and tear; however special precautions are required when disturbing / removing
 - minor areas w/ evidence of moisture in slab w/ efflorescence & minor tile lifting; due to previous use locations suggest surface moisture rather than under slab migration
 - note it is a common practice to install new flooring over older linoleum as vapor barrier protection & to avoid added expense to remove asbestos containing materials

floor damage from efflorescence / moisture

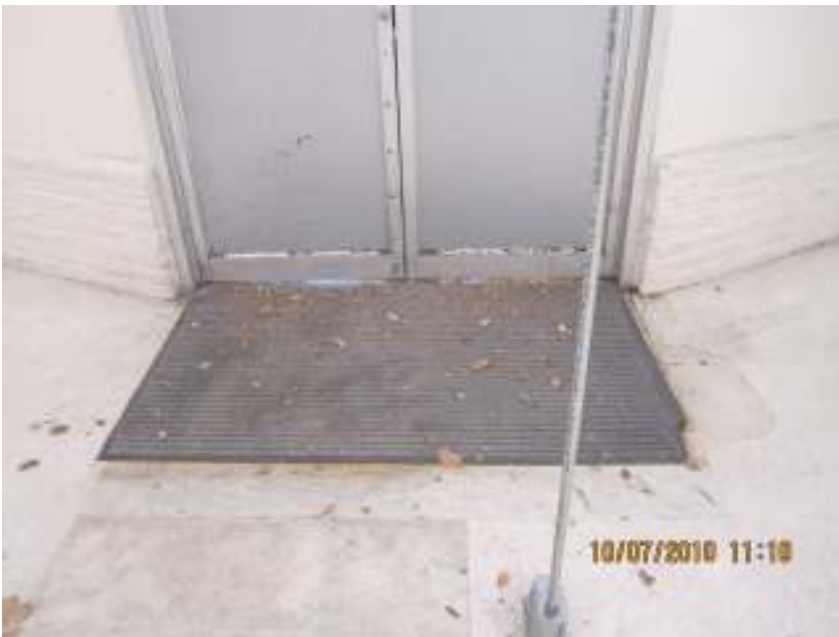
- aluminum store doors @ front / south side; older w/ poor weather seals
 - overhead garage door in serviceable condition
- windows
 - newer vinyl thermal pane, serviceable condition

SW entry door w/ poor weather seal

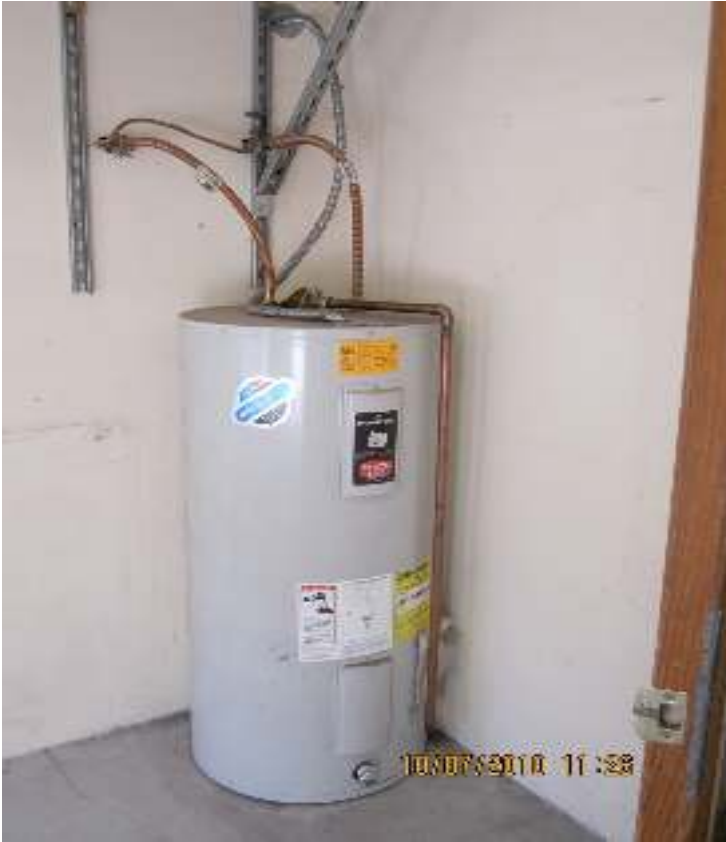
- water heaters:
 - 2007 38 gallon electric tank, @ laundry / bathroom, installed to code
 - 1999 50 gallon electric tank, in garage, @ end of economic life span, missing code required seismic strapping & insulation pad

older water heater, not to code

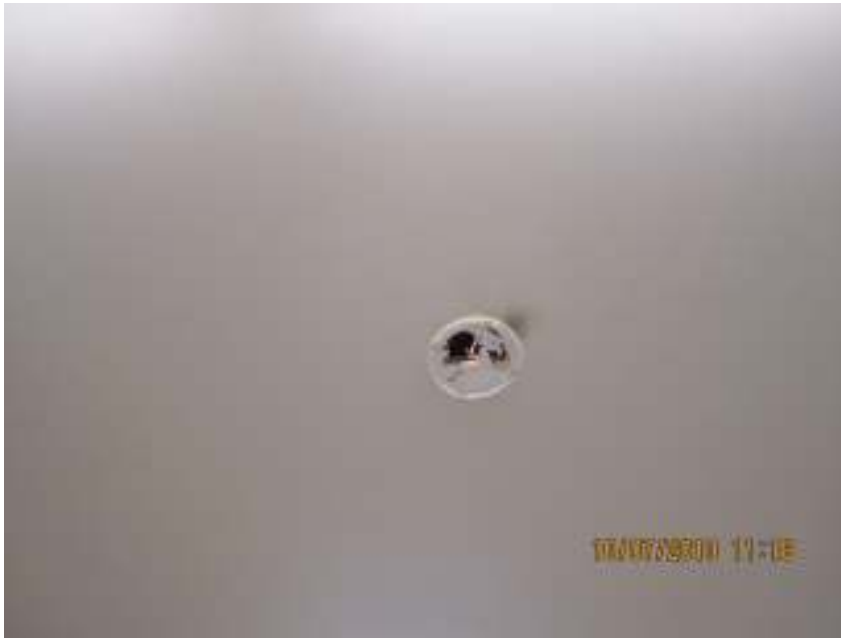
missing smoke detector

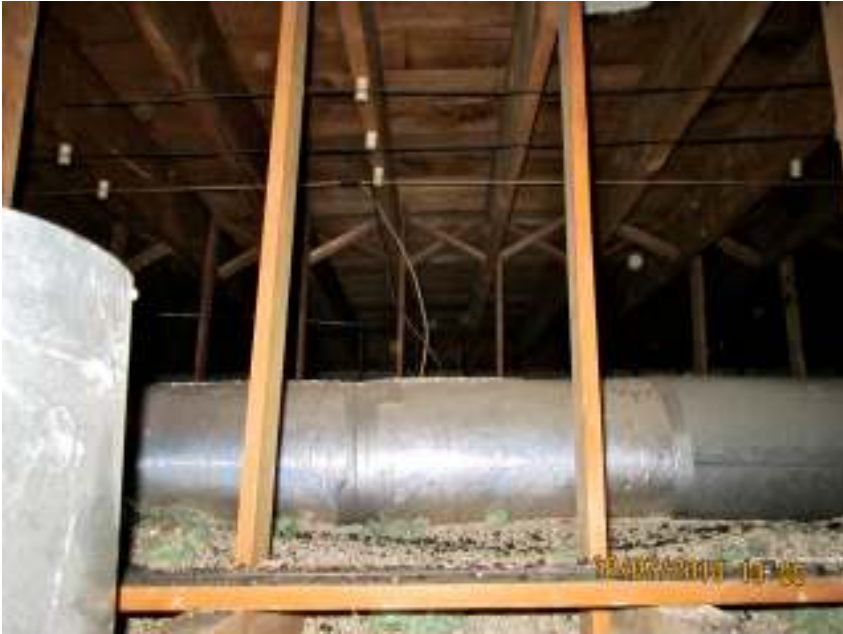
- hazardous material identification regarding flooring & adhesives, older
layers under linoleum tiles not performed
- note, vermiculite attic insulation, over office area, was tested by NVL Labs
w/ report attached and no asbestos was detected; this material has
been known to contain asbestos but in this case no concern; I
recommend retaining a copy of the report in the case that future
remodeling, rewiring & remodeling may bring up the issue

vermiculite office attic insulation

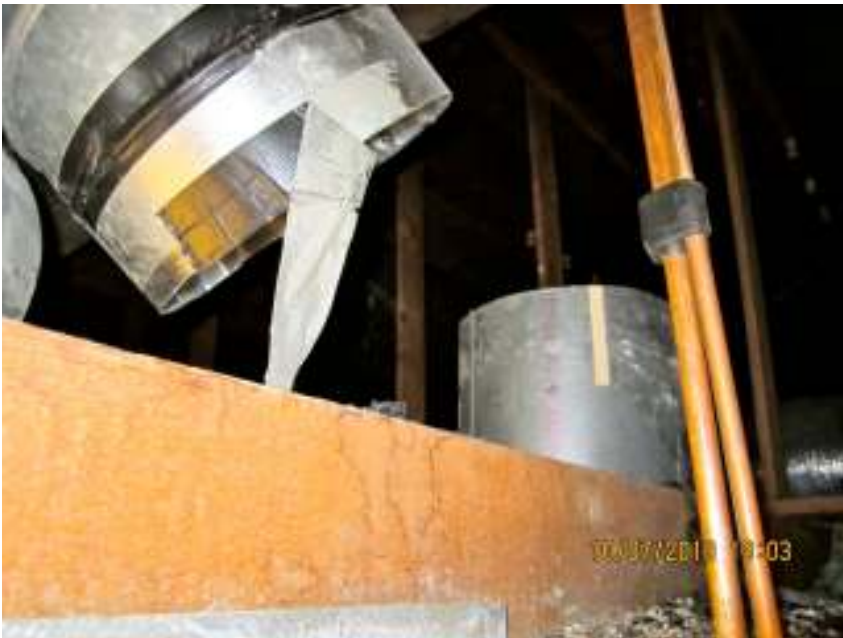
- some open ducting observed above the drop ceiling, unknown if abandoned or still in service
 - 3 heat pumps observed:
 - model number B3CH060A06C, serial number NEGM059599 charged with R22

open attic duct work
