HOME & BUILDING SERVICES, inc.
Townhouse Buyers Inspection Report

XXX Whitworth Place South
Renton, WA 98055

Date: 16th of November 2018 Time: 12:00 PM

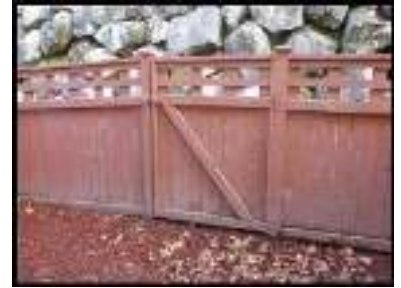
Wood: General condition is serviceable.
Note: areas with soil contact with early signs of decay.

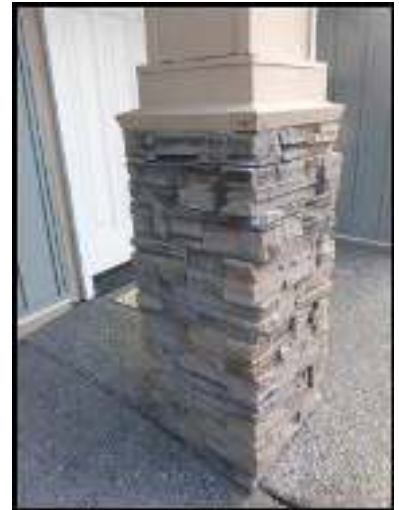
Note: minor scraping damage at the driveway exposure.

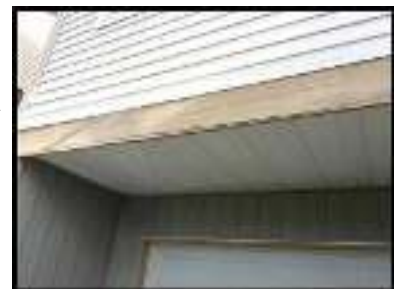
Serviceable with a large trim board cracked above the overhead door.

Some of the trim is a product marketed as "white wood" was installed as the exterior trim. This material is typically southern pine or spruce and considered a soft wood and will damage easily in areas of failed paint and sealant. It is not considered an exterior material in our damp climate. Regular heavy paint coatings and sealant maintenance are required to prevent decay and rot.

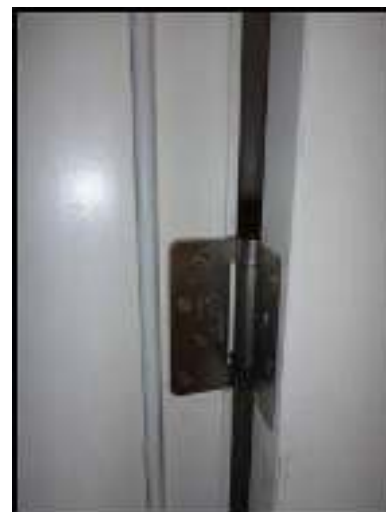
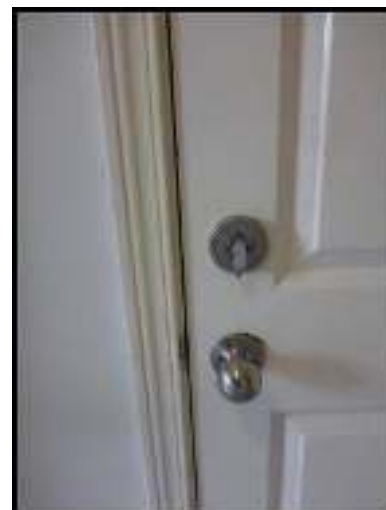
Loose hinge screws observed, need corrections to latch properly.

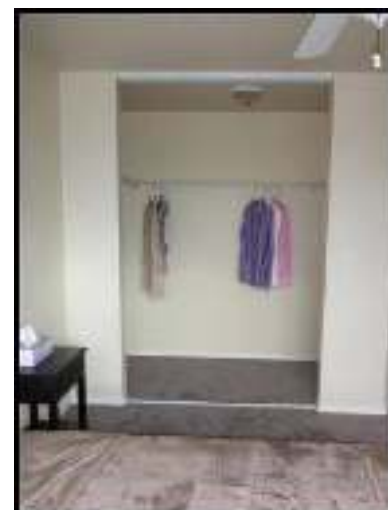
7.4 DOORS: Missing bedroom closet bi-pass doors, 2 sets.

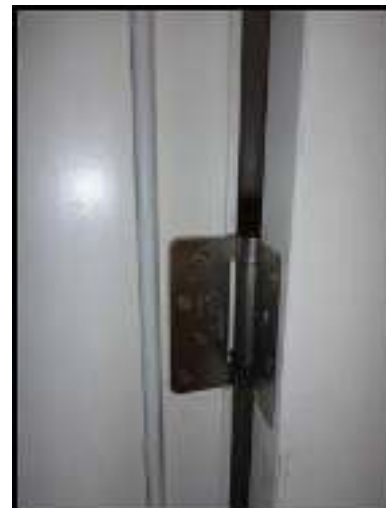
Note: some hardware / knobs loose and poorly aligned.
Inexpensive hardware, consider future replacement.

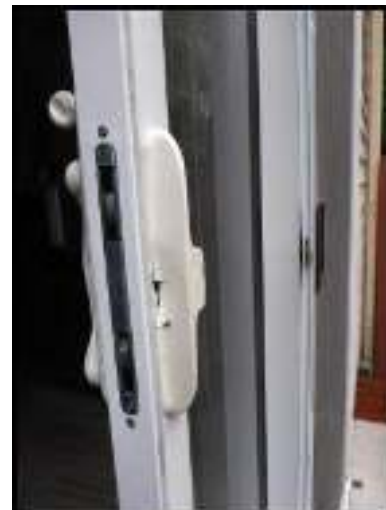
Both sliding doors with loose hardware.
Damaged at the patio door.

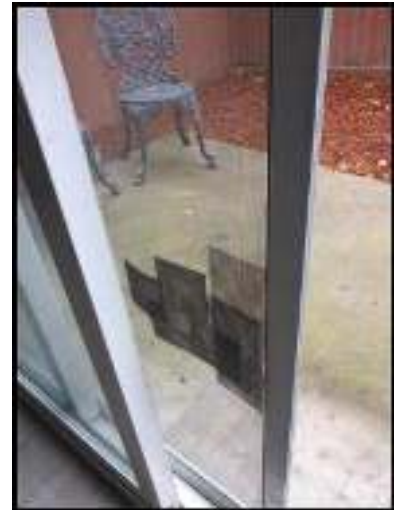
Both screen doors with heavily damaged screens.

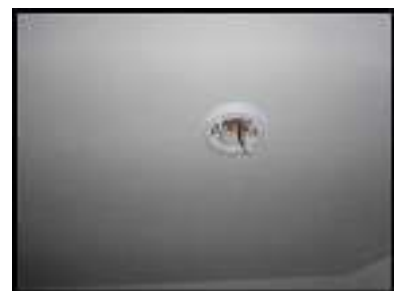
7.15 CARBON MONOXIDE DETECTORS : **None Observed, install to current standards, laws and codes.**
New laws require installation on all levels of home and in close proximity to all bedroom doors. Install prior to closing.

7.16 SMOKE DETECTORS : Two removed hardwired detectors (with battery back-up).
Some older units observed, over ten years old. Recommend replacement.

NOTE: recommend replacing, on all three levels, the smoke detectors (missing at the upper level) with combination smoke carbon monoxide detectors. Codes and standards require hardwired detectors with battery back-up on every level of the home, in close proximity to all sleeping rooms.

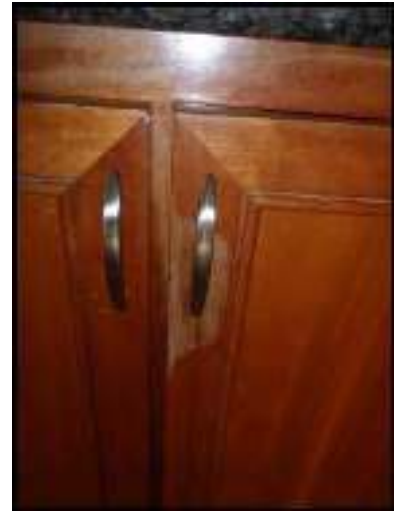
Areas of warn or damaged finish.

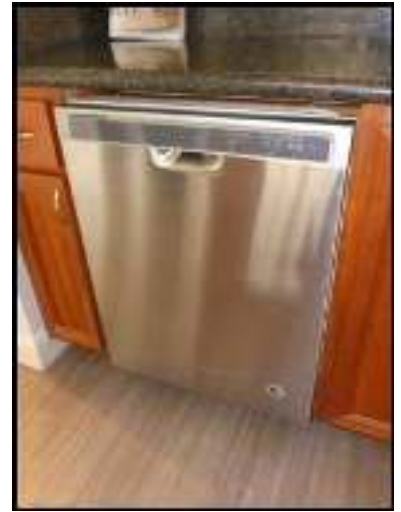
8.9 DISHWASHER: Not installed properly, loose in opening, needs corrections.

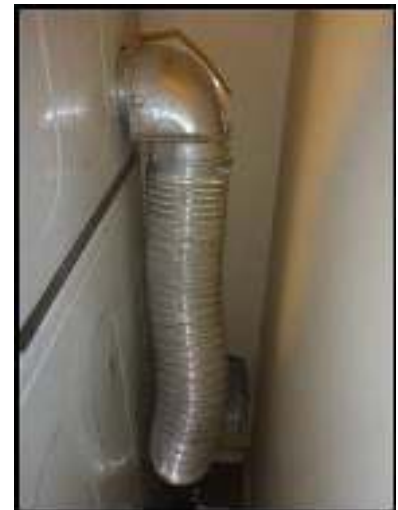
The dryer vent is vented to the outside.
Note: vented through the attic.
Recommend cleaning, where accessible, and monitor drying times for air flow.

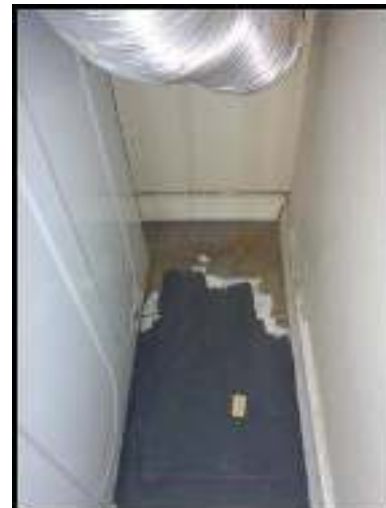
9.11 FLOORING: Poor, partial painting of flooring.

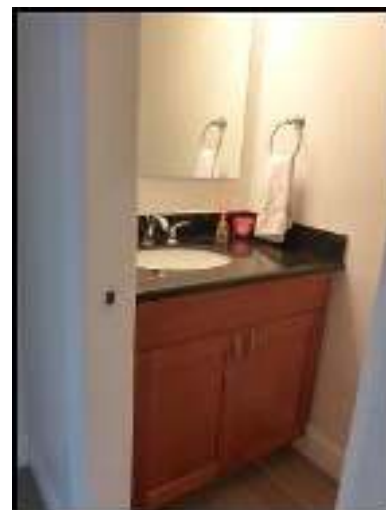
10.1 CONDITION: Repairs / corrections needed.
Non professional drain work observed.

Non professional drain alterations. Missing required p-trap. Repairs / corrections needed to prevent sewer gases from entering the home.

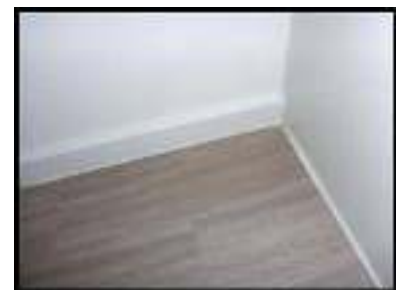
10.11 FLOORING: MDF (medium density fiberboard) baseboard with water damage at the bath tub. Caulk and maintain seals to the flooring to prevent future damage at tub / shower / toilet.

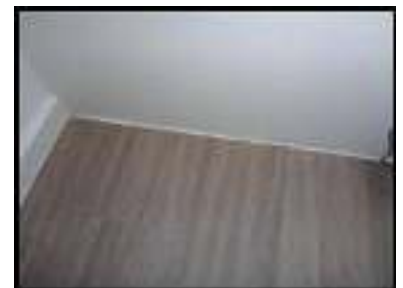
10.22 BATH TUB: Sealant / caulking needs renewal at the floor / tub seam.

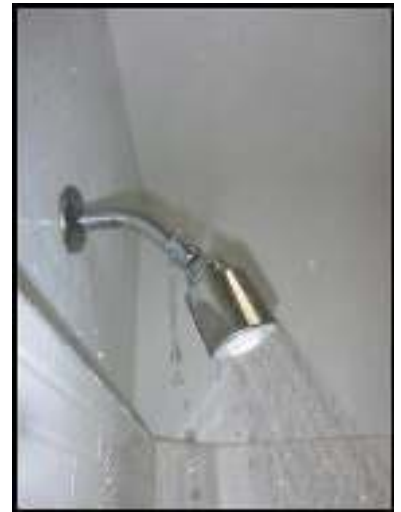
Shower head with heavy leaking at the threads.
Repairs needed.

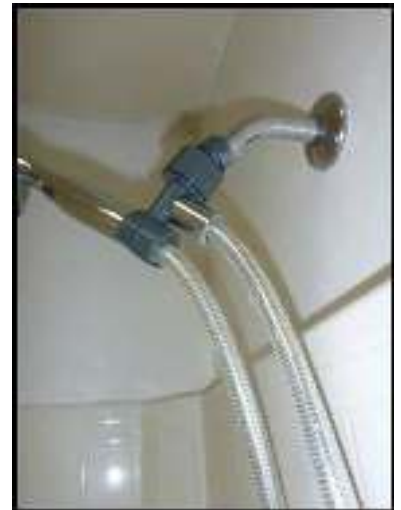
The showerhead fittings leak during use.

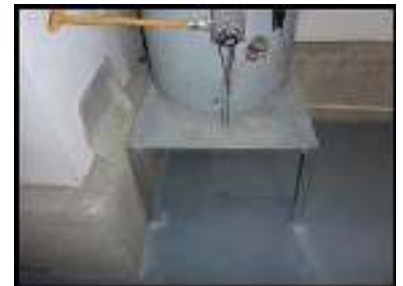
12.2 VISUAL CONDITION: At end of economic life span due to age.
Recommend replacement prior to failure to prevent water damage.

Recommend replacement prior to failure to prevent water damage. NOTE: change of use and life styles is a common cause of failure of older tanks.

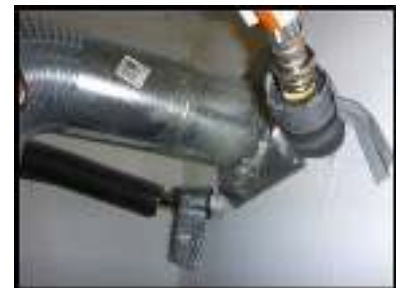
All exposed water pipes should have insulation installed and improved.

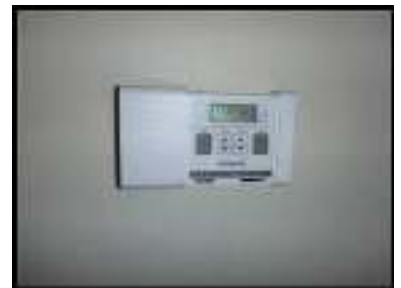
13.11 THERMOSTAT: Serviceable, functions not tested. Missing cover.
