Michele and Scott XXXXX  
##### Drive SE  
Olympia, WA 98513

Consult Address: ##### SE ##<sup>h</sup> Street  
Mercer Island, WA 98040

Consult Date: January 2<sup>nd</sup> 20XX  
Consult Focus: Investor Consult

## **CONCLUSIONS**

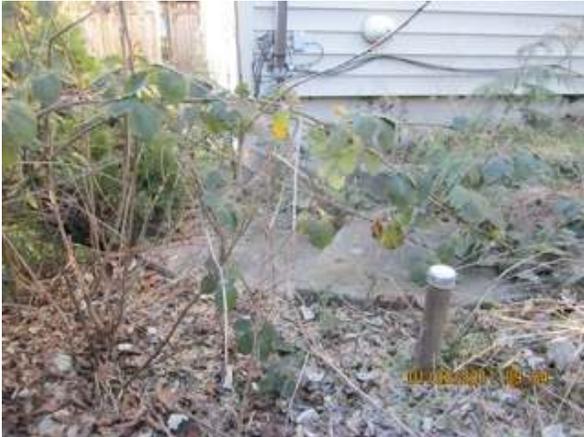
- 1.1. an buried oil storage tank is in service & located @ the SE corner of the home
  - 1.1.1. due to plans for future removal of existing home & tank, a few soil samples should be taken next to the tank, along the homes foundation wall & under the tank
  - 1.1.2. *recommend a licensed & qualified tank specialist or soils engineer test soils*

1.1 oil tank filler spout @ SE corner of house

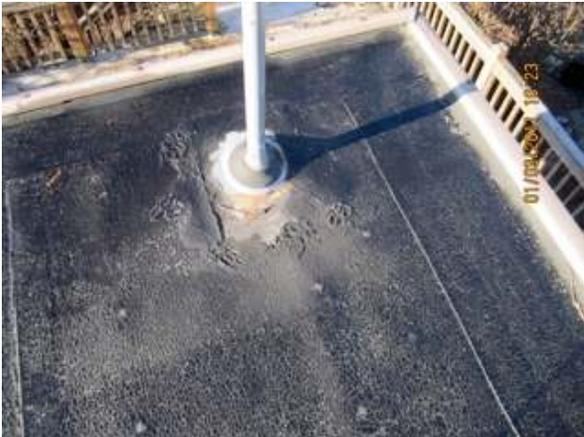
- 3.1.1. main roof:
  - 3.1.1.1. older roof starting to fail w/ loose granules
  - 3.1.1.2. poorly tied in to flat roof addition
  - 3.1.1.3. leaking @ flat roof downspout transitions
  - 3.1.1.4. *maintain seals @ flat roof transitions & monitor*
- 3.1.2. flat roof addition @ SW corner
  - 3.1.2.1. aging w/ heavy cracking
  - 3.1.2.2. *apply sealer coat*
- 3.1.3. loose downspouts:
  - 3.1.3.1. *secure as needed*
- 3.1.4. *recommend a roofing contractor coat flat roof & maintain seals @ transitions to pitched roof; monitor*

3.1 aging torch down roofing @ flat SW corner

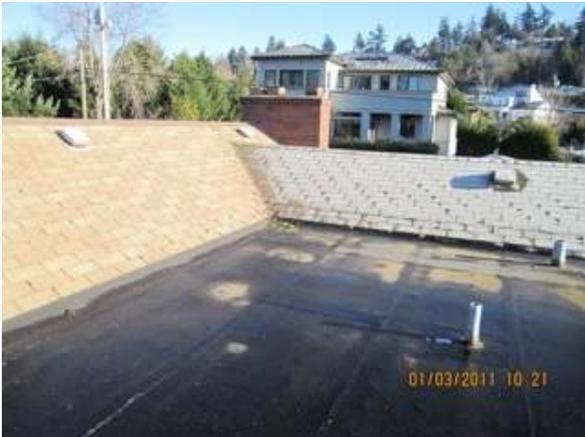
3.1 failing 3 tab composition roofing

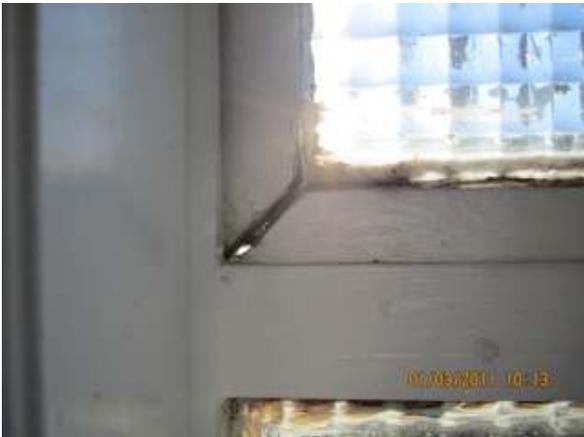
- 2.3.1. south side main floor bathroom window w/ damaged frame
    - 2.3.1.1. not operable w/ gaps
    - 2.3.1.2. *recommend replacement w/ inexpensive vinyl window*

10.2. south side main level bathroom window frame

2.3 failed south side bath window

8.2.1. main level bath window w/ damaged, inoperable; *replace*

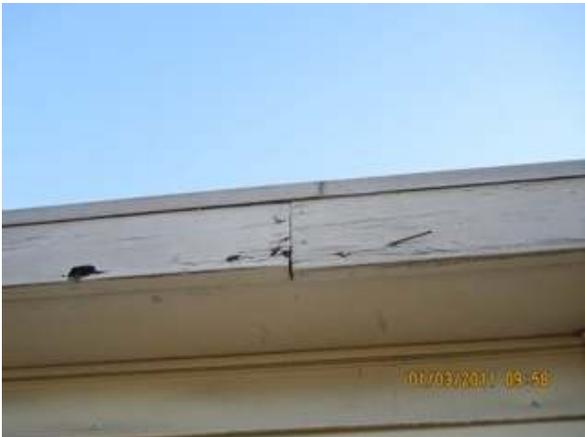
- 2.6.1. fungal rot observed @ roof edge trim, west side of flat roof area
  - 2.6.2. *seal roof edge flashing & monitor*
- 2.7. fence w/ missing sections & damaged gates

10.1. fascia @ WSW roof edge

2.6 fungal rot @ WSW fascia

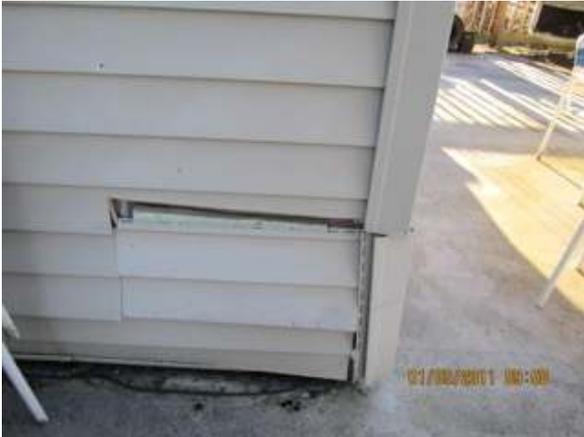
- 2.3.2. several windows cracked & failed seals
    - 2.3.2.1. entry window w/ safety glass
    - 2.3.2.2. *recommend repairs as needed for safety*
- 2.4. vinyl siding w/ loose & open sections

- 2.4.1. repairs needed to prevent water intrusion & leaking
  - 2.4.2. areas of previous repairs & damage
  - 2.4.3. *re-install & seal as needed (minimal repairs recommended)*

2.4 poorly patched vinyl siding

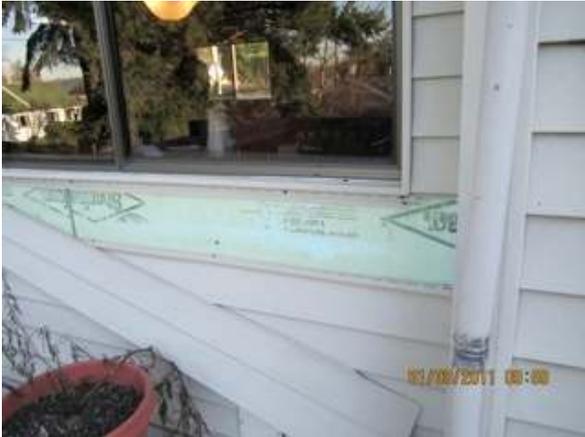
2.4 loose vinyl siding

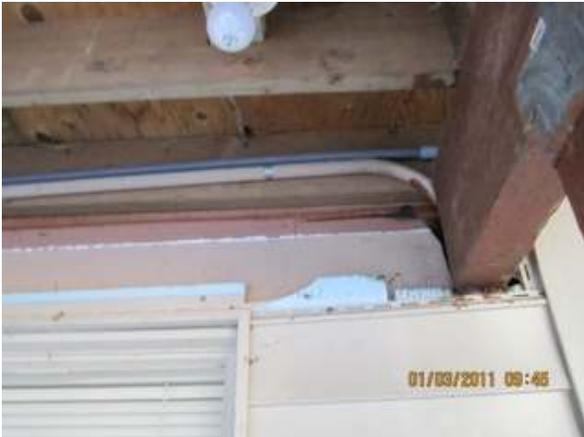
2.4 missing siding

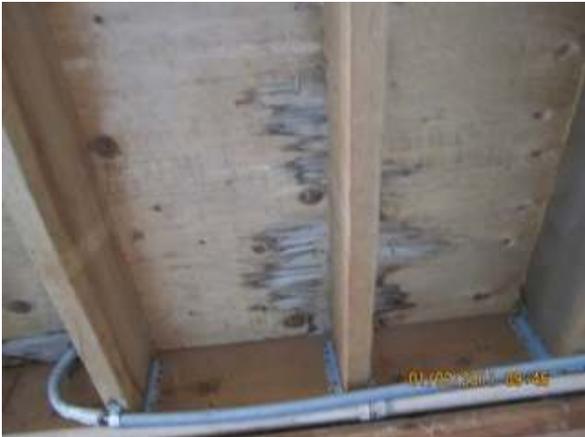
- 2.2.2. water proof membrane w/ evidence of minor leaking
    - 2.2.2.1. *recommend caulking & maintaining seals @ all transitions / post bases*
- 2.3. windows:

2.2 & 2.6 leaks @ water proof deck membrane

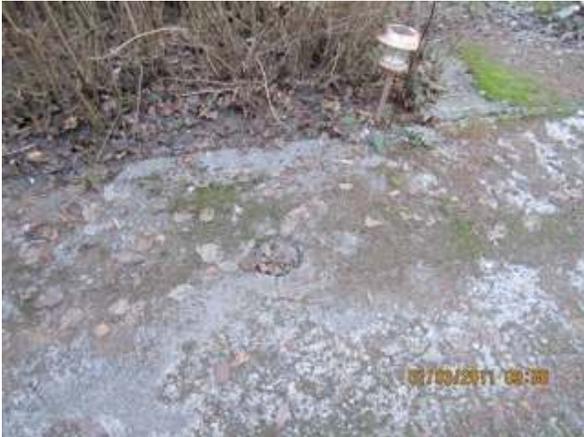
- 2.5. drainage:
  - 2.5.1. roof / gutters overflowing
    - 2.5.1.1. *clean & flush gutters & downspouts*
  - 2.5.2. blocked / full driveway drain
    - 2.5.2.1. driveway drain, next to garage door, blocked w/ organic debris

2.5 driveway drain, blocked

- 2.5.2.2. *clean, flush & maintain*
  - 2.5.3. street drainage ditch
    - 2.5.3.1. *keep clear of debris during fall & winter rains*
- 2.6. fascia / trim

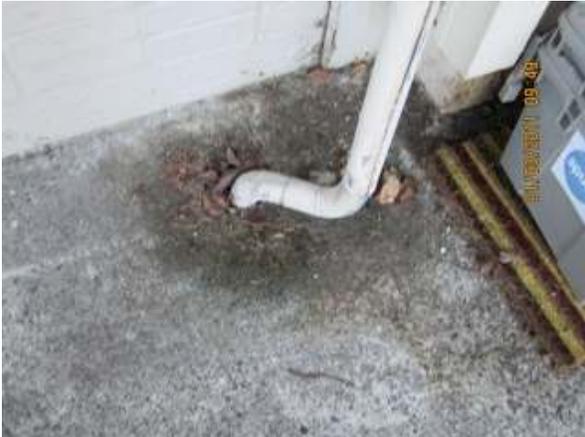
2.5 slow driveway & roof drain @ west side

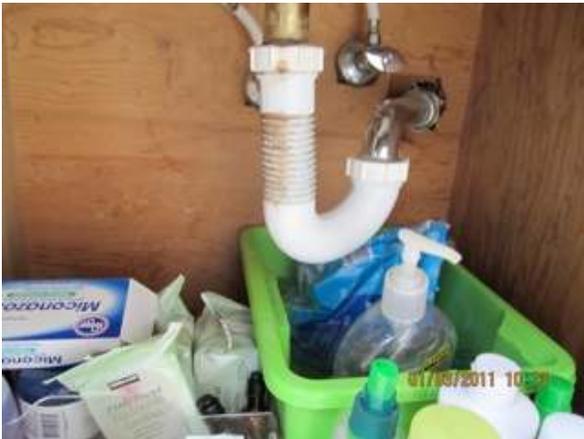
- 6.1. furnace needs full inspection, testing & servicing
  - 6.1.1. 1946 forced air oil furnace w/ no evidence of recent service or maintenance
  - 6.1.2. *recommend a licensed & qualified HVAC technician inspect, test & service all components*
  - 6.1.3. *recommend installing carbon monoxide detectors on both levels*
- 6.2. water heater not observed
- 6.3. plumbing repairs (recommended):
  - 6.3.1. main level hall bath:
    - 6.3.1.1. left sink leaking @ drain fittings below
    - 6.3.1.2. tub w/ slow drain (& failed finish)
  - 6.3.2. lower level bath:
    - 6.3.2.1. toilet loose; *remove & replace wax seal & secure to floor*
    - 6.3.2.2. note shower not tested due to stored items

6.3 active leaking main level bath sink drain

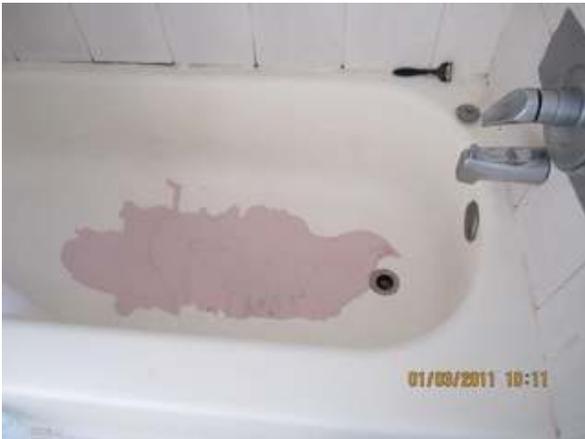
Items that may need some attention, for potential future tenants might include a new painted finish on the bathtub and replacement of the pet urine damaged carpet in the lower level.

failed painted bath tub finish

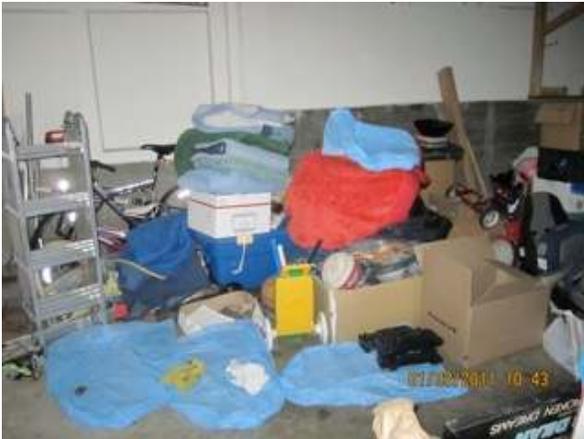
extensive storage & limited access

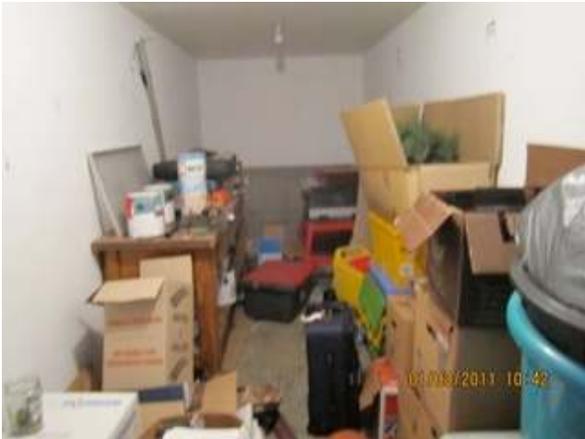
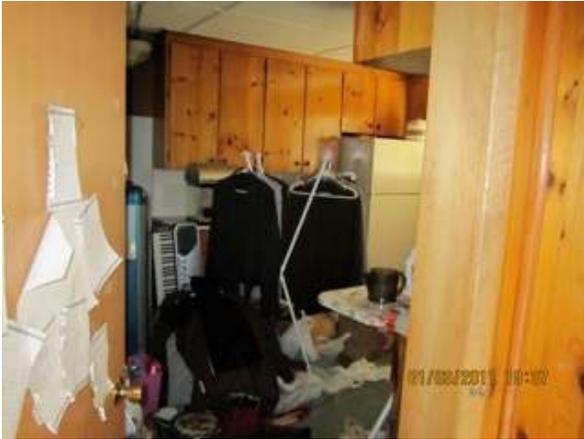
extensive storage & limited access
