HOME & BUILDING SERVICES, inc.
Townhouse Buyers Inspection Report

XXX Whitworth Place South
Renton, WA 98055

Date: 16th of November 2018 Time: 12:00 PM

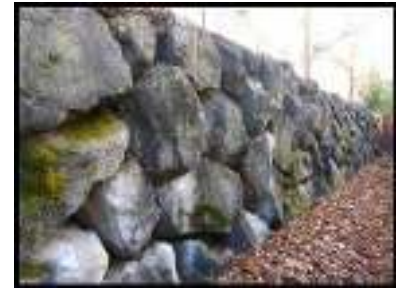
2.1 LOT TYPE: Sloped complex with retaining walls and a foundations built into the hillside.

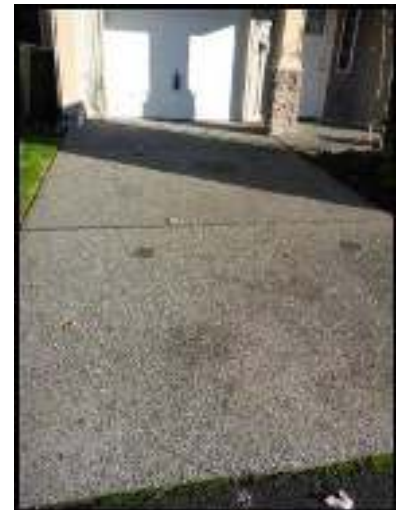
2.4 DRIVEWAY: Concrete in serviceable condition.

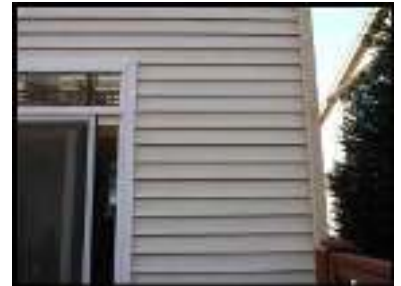
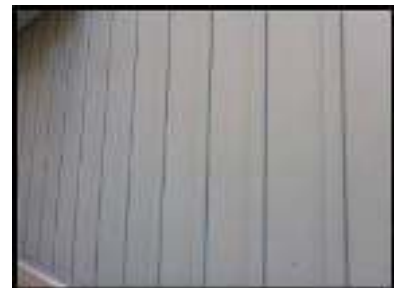
The siding appears to be in serviceable condition.
Type: Vinyl.

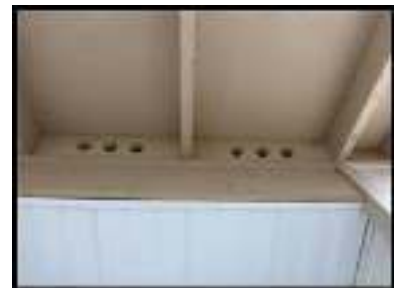
Open with screened venting.

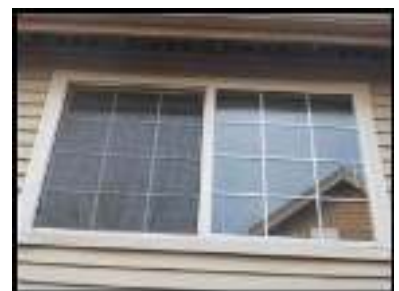
Vinyl thermal pane.

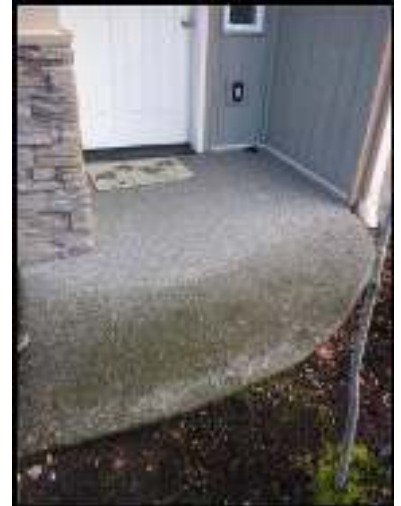
2.22 TYPE: Concrete - Serviceable.

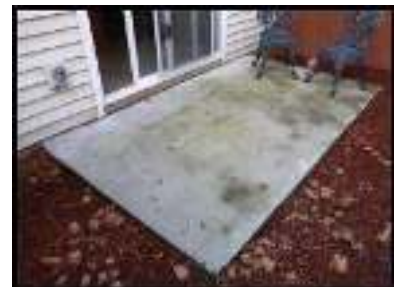
2.24 TYPE: Concrete - Serviceable.

2.25 REMARKS: Needs cleaing / pressure washing.

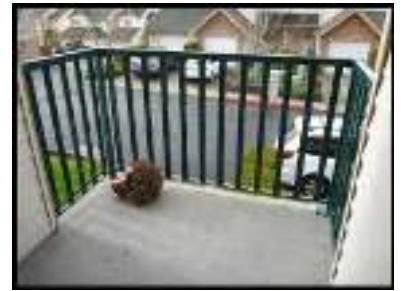
Serviceable.

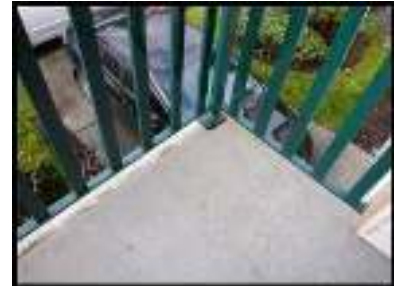
Fabric water proof membrane in serviceable condition.

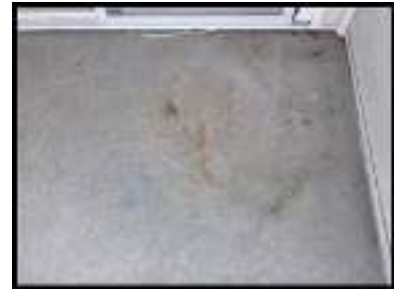
Some staining may not clean.

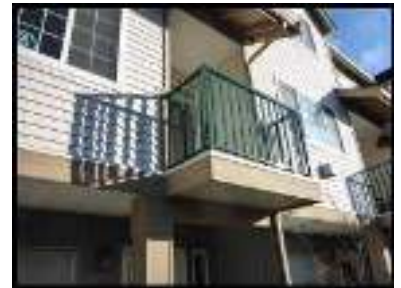
Serviceable, To current standards.

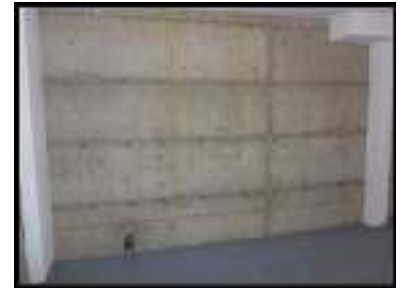
3.2 FOUNDATION CONDITION: Serviceable with no irregularities observed.

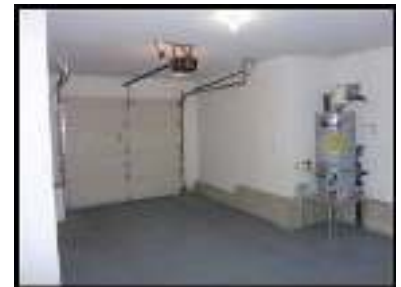
4.1 GENERAL CONDITION: Serviceable.

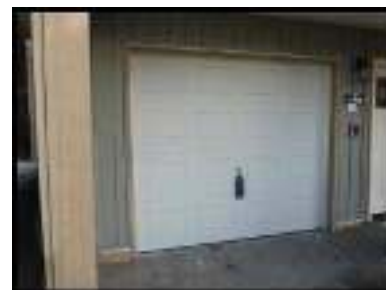
Serviceable.

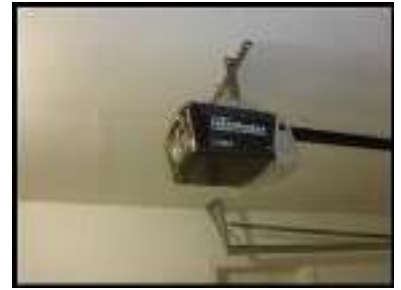
Automatic door opener(s) is/are operational. Remote controls for the opener is beyond the scope of the inspection.

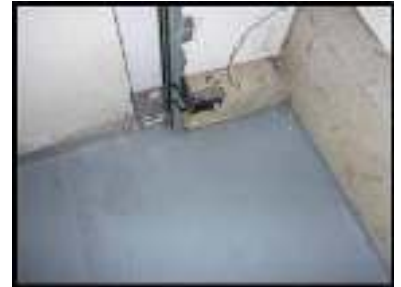
The safety reverse system is in serviceable order.

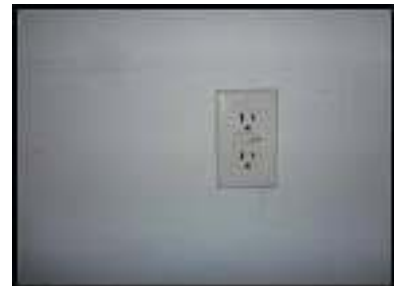
To current standards, GFCI protected.

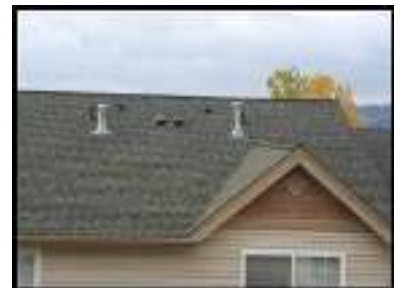
The roof appears to be consistent with its age and is performing as expected within its estimated life expectancy. Routine maintenance will aid in achieving maximum life.

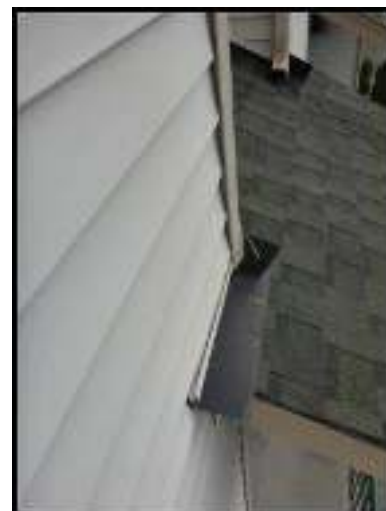
The metal is in serviceable condition, consistent with the age of the materials.

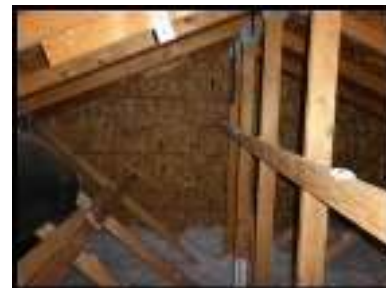
6.1 CONDITION: Serviceable, conditions are consistent with the age of the home.

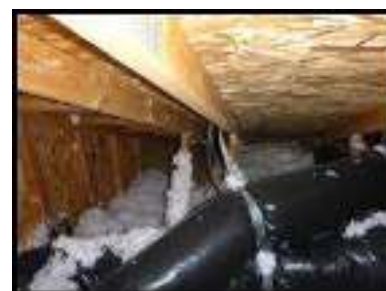
6.5 ROOF SHEATHING: Good. Oriented Strand Board sheathing.

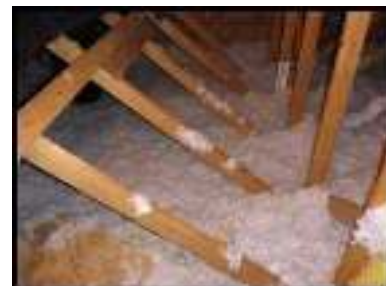
6.6 TRUSS SYSTEM: Manufactured trusses observed in serviceable condition with no visible irregularities.

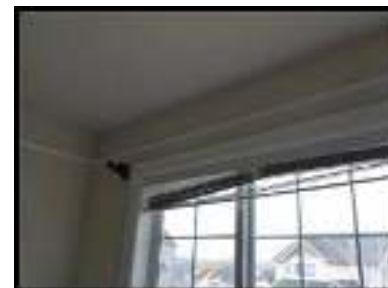
7.3 WINDOW DAMAGE: Living room blinds damaged and need replacement.

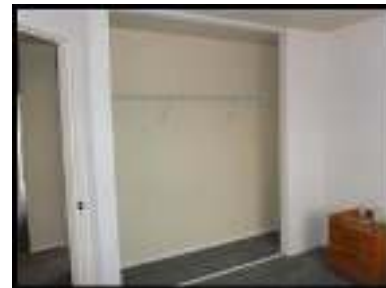
Missing laundry closet bi-fold doors.

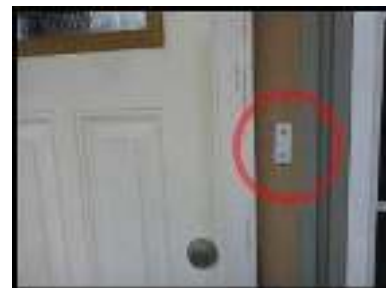
Missing entry door bell.

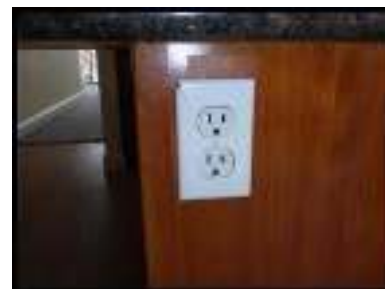
Two broken / cracked cover plates needing replacement.

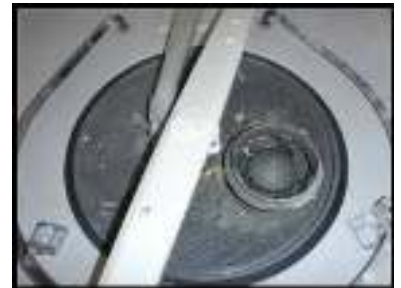
Heavy debris build-up inside of the unit.

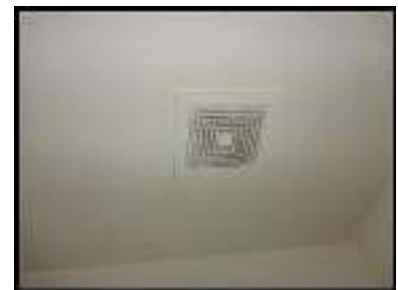
Functioning
Needs cleaning.

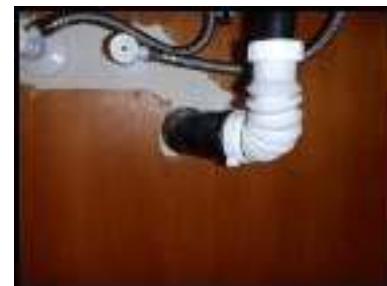
Non professional drain alterations. Missing required p-trap. Repairs / corrections needed to prevent sewer gases from entering the home.

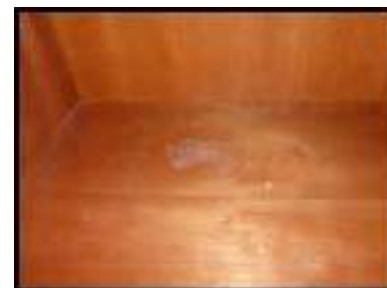
None were visible at this time with evidence of previous leaking observed under sinks, monitor.

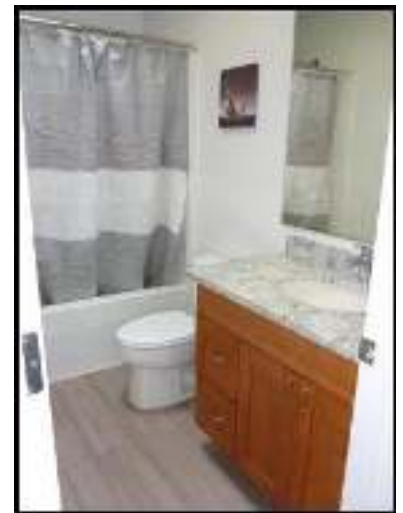
10.10 CONDITION: Repairs /corrections needed.

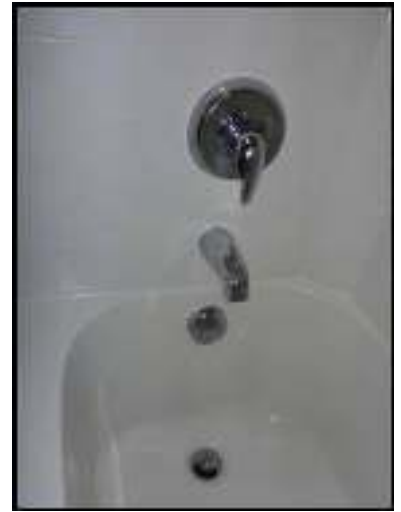
Shower head with heavy leaking at the threads.
Repairs needed.

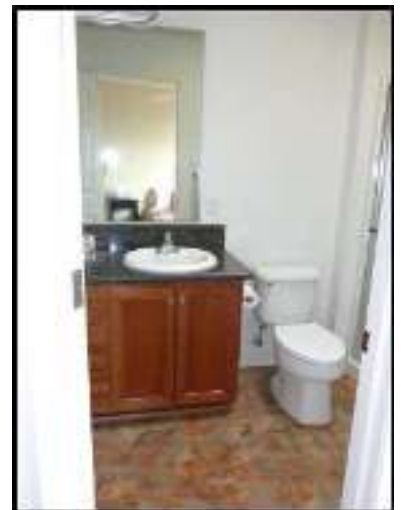
10.26 FLOORING: MDF (medium density fiberboard) baseboard with water damage at the bath tub.
Caulk and maintain seals to the flooring to prevent future damage at tub / shower / toilet.

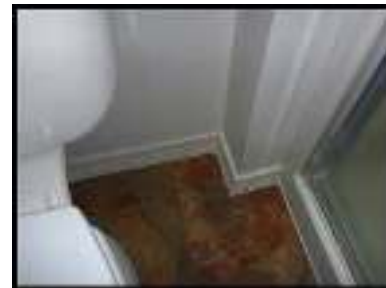
Paint mess on flooring.

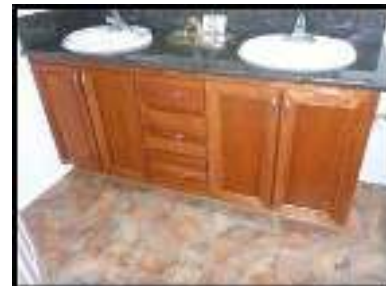
10.30 COUNTERTOPS: Renew / replace sealant at the counter top back splash seam.

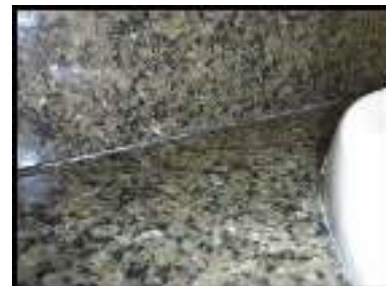
10.31 SINK: Two.
Left sink disconnected and needs repairs.

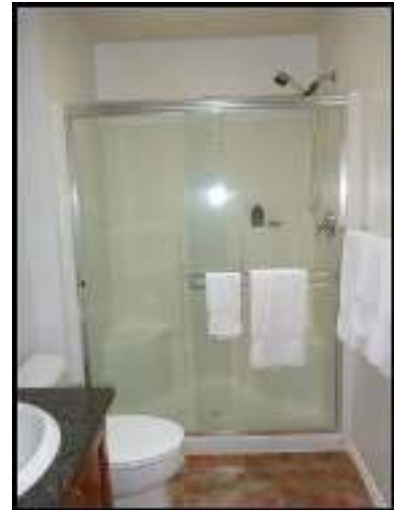
The showerhead fittings leak during use.

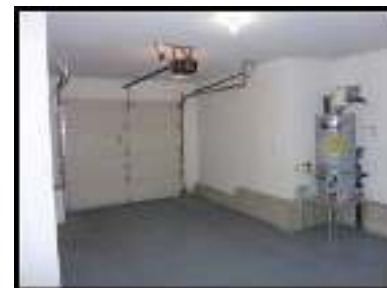
12.2 VISUAL CONDITION: At end of economic life span due to age.
Recommend replacement prior to failure to prevent water damage.

Recommend replacement prior to failure to prevent water damage. NOTE: change of use and life styles is a common cause of failure of older tanks.

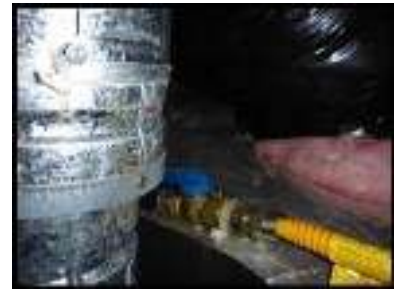
13.10 FILTER CONDITIONS: Hall ceiling access panel damaged and needs replacement. Pleated paper filter not properly installed and allowing blow-by (unfiltered air).

13.13 REMARKS: Recommend a full inspection, testing and servicing prior to closing. Recommend replacing the damaged filter access panel in the upper level hallway.

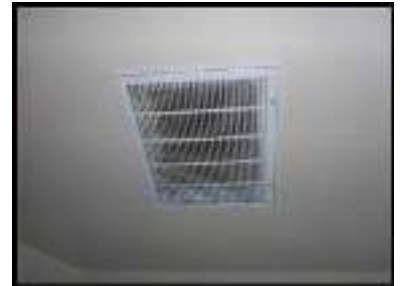
13.11 THERMOSTAT: Serviceable, functions not tested. Missing cover.

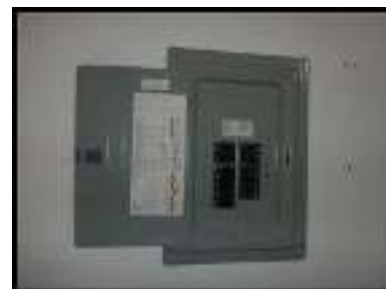
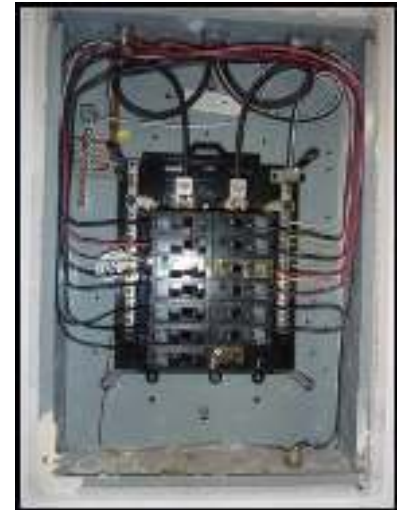
14.6 PANEL CONDITIONS:

The visual inspection did not reveal any significant negative conditions and appears serviceable.

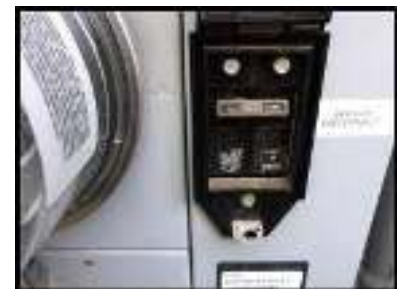
14.7 MAIN DISCONNECT SIZE: 70 amps.

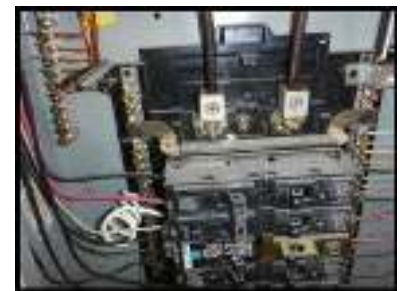
14.8 SERVICE ENTRY CABLES: Aluminum cable.
